Coil Spring Removal

"An accident waiting to happen" (Part 1)

by Bob Mannel

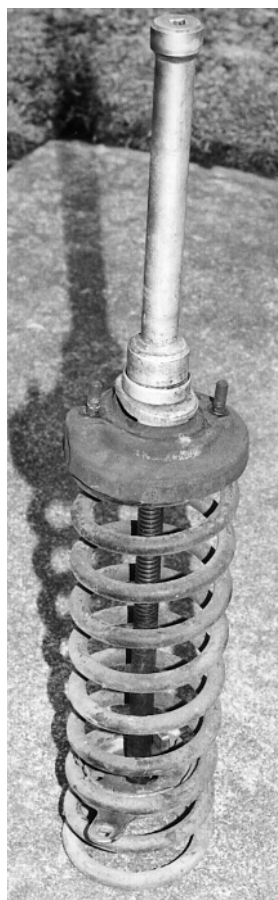
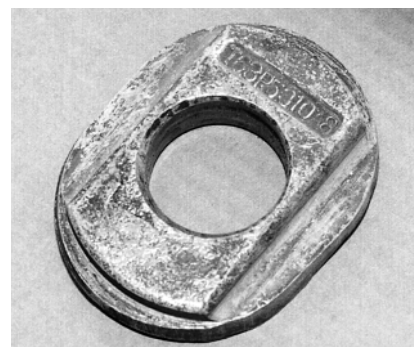
As with the Moog tool, the upper plate fits into the upper coil spring seat and is sized to slide through the opening in the shock tower, allowing the spring and upper seat to be removed as an assembly. The lower plate has a 1/2" square hole on the handle to keep the plate from turning, should that be necessary.

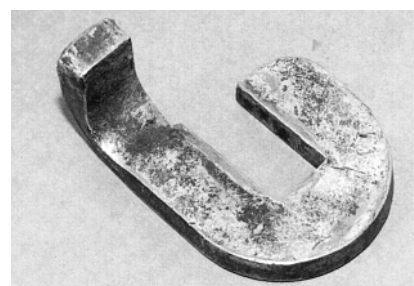
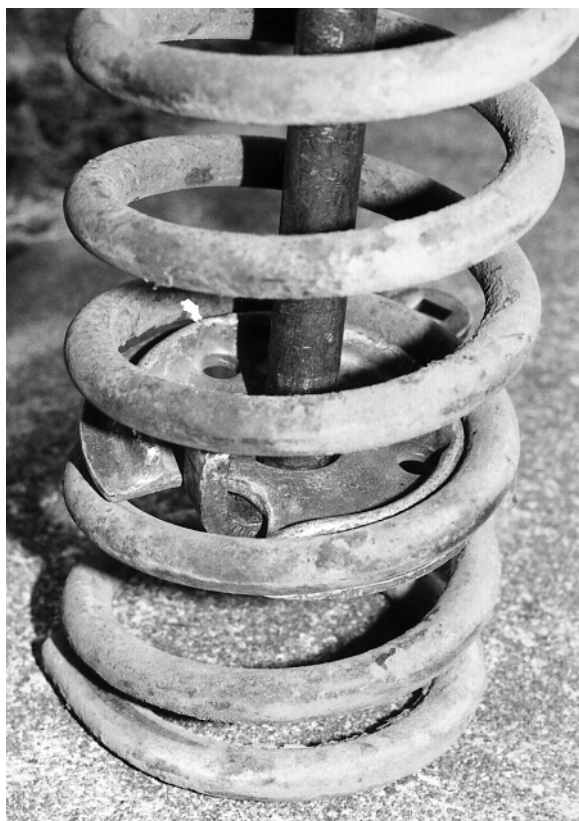
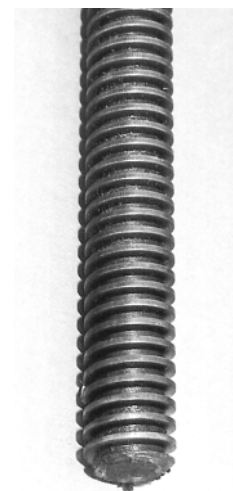
The Ford spring compressor tool is well-designed, although a little cumbersome in the way the lower plate attaches to the shaft. It requires maneuvering the J-hook through the coil spring and sliding it in position on the shaft, and then engaging the upper tab into the lower plate. Once that is accomplished and the slack removed, it works well. I was a bit concerned that the full spring force was supported only along the edges of the slot in the center shaft. If the J-hook is fully seated on the shaft, then three edges are supporting the load. If not fully engaged, then only two edges are supporting the load. It seemed a rather small area for such a high load, but the metal is tempered and seems to do the job. As with the Moog tool, ACME threads are used on the center shaft, which are specifically designed for high loads.

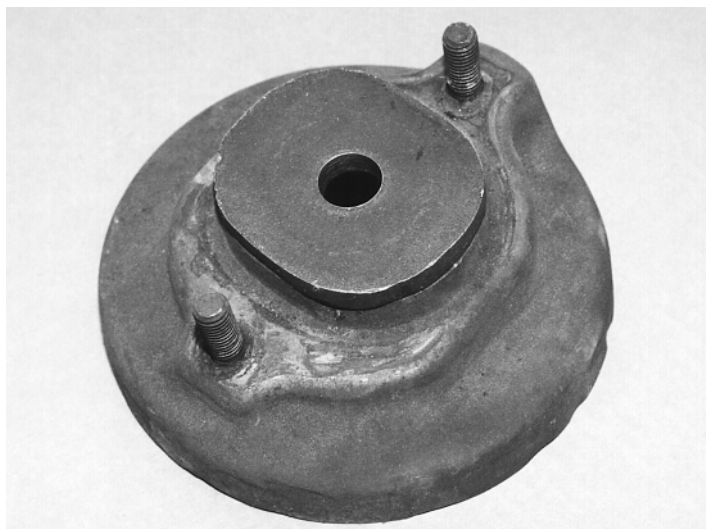
index the top plate so that it cannot shift. The photo above shows Myron's upper plate. The illustration to the right of the above photo shows a full-scale representation of the top plate which will rest on the upper coil spring seat, but still clear the opening in the shock tower. The thinner, inner line is where to index the top plate so it can't shift. The indexing need not be fancy. Just a little welding rod in four places should do the trick. You just don't want this plate to slip off the upper spring seat for any reason!

That's what Myron did. I would recommend a couple of refinements to his design. First, use at least a 3/4" diameter threaded bar, 1" is even better. There is no reason not to use a nice thick bar that you know will never break. Second,

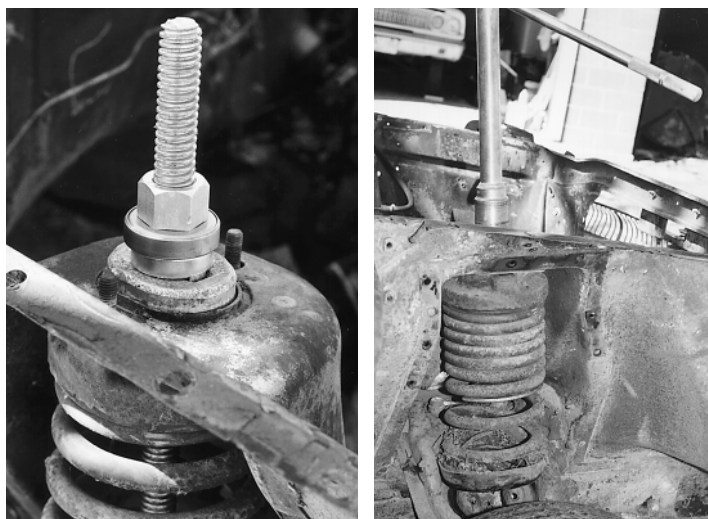
When the tool is snugged up, there should be just under 4" of threads exposed above the nut (*left above*). The coil must be drawn up until just prior to coil bind above the plate. Anything less and the coil will not clear the A-frame seat. Although the shop manual calls for an impact wrench, I used a breakaway bar and it was quite easy to turn the shaft. I would recommend against using the impact wrench so that you do not try to tighten the tool after coil binding occurs. This severely loads the tool and is dangerous. By using hand tools to turn the shaft you will immediately feel the binding. I just watched and stopped when I couldn't see any more space between the coils.

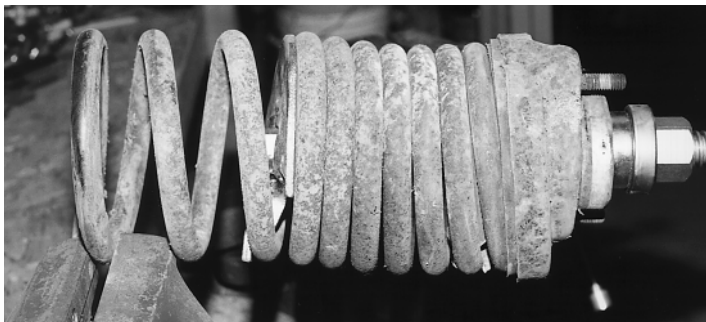
Once the coil spring was removed from the car, I felt very comfortable handling it attached to the tool (*above*). The next step was to clamp the spring in a vice. About 7 1/2" of

threads are exposed before the loosening begins. It is a good idea to note this measurement for the time of re-installation. The shop manual (*illustration below*) shows where to make scribe marks before removing the tool. These will simplify re-installation. The manual talks about the "narrow side" of

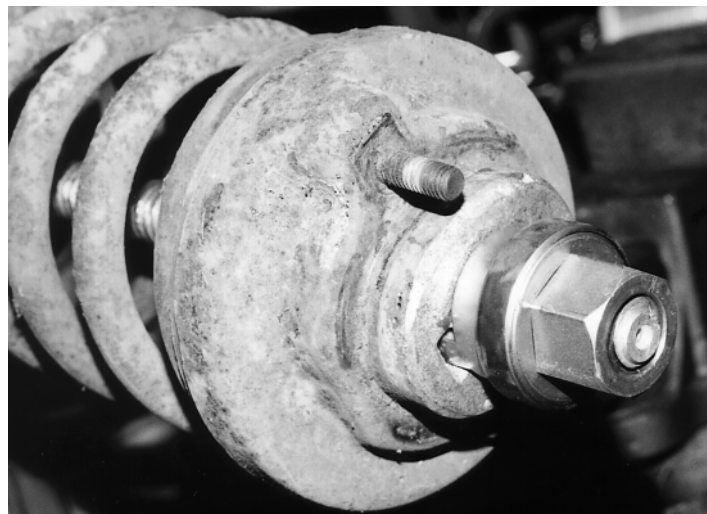
Once all the coil spring tension has been released, not many of the tool's threads remain visible (*above*). Positioning of the tool is crucial as you don't want to run out of threads with tension still on the coil.

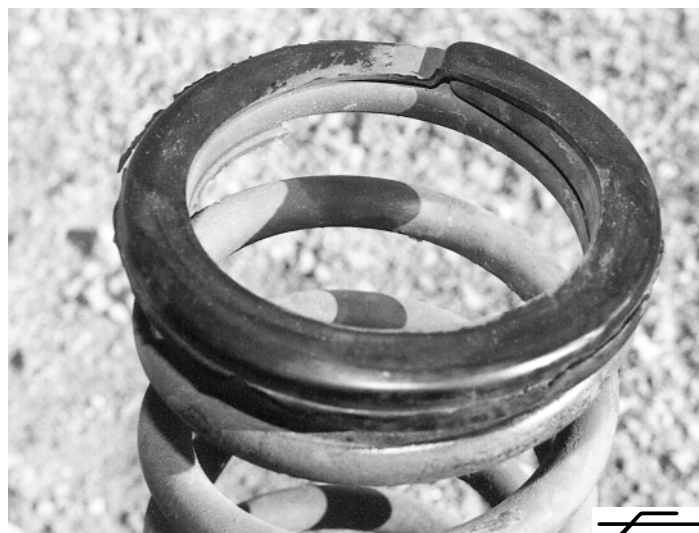
In 1964 Ford replaced the two-piece arrangement with a single-piece rubber boot (*below*). It incorporated the upper cup and rubber between the first two coils as one piece. The 1962-63 two-piece boots and 1964-65 single-piece boots can be swapped as desired.

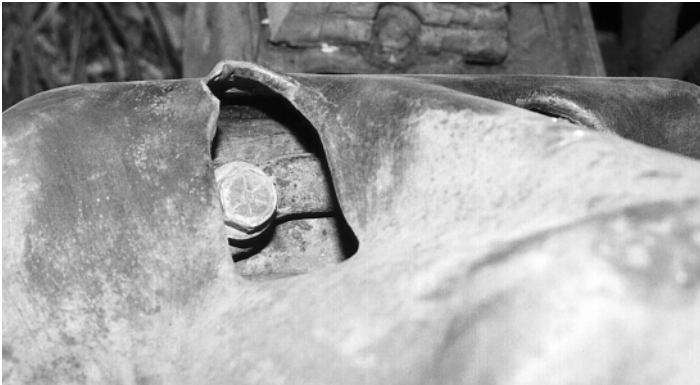
Having the actual alignment of the 1962-65 Fairlane and 1962-63 Meteor performed always caused me to grit my teeth because no shop ever had the special tools needed. Instead, the alignment man would loosen the inner shaft bolts and begin prying against the slots in the shock towers. And when that didn't work, he just got a bigger pry bar, or added a piece of pipe for more leverage. By the time he got done, you might have a shock tower that looked like the one above. More than likely, you were never

told—and it might be doubtful that your Fairlane front-end was actually aligned!

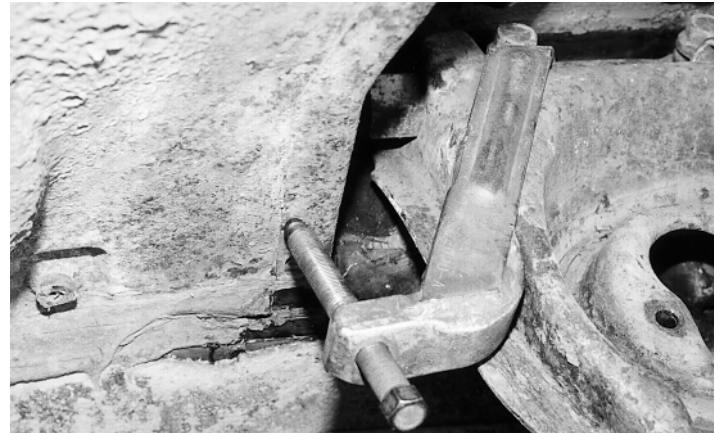
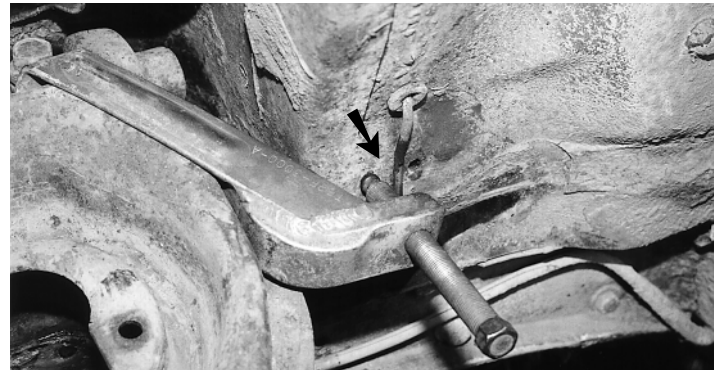
Ford had its own special tools for this job. The ones shown on this page were borrowed from Jack Grice. They are complete except for the foot-pads at the ends of the screws. The tools fit over the A-frame and snug against the side. The pads rest against the sheet metal and might be off the area where the sheet metal is of double thickness. Also, note that the foot of the jackscrew on the tool installed aft (*see arrow on photo at immediate right*) is very near the brake line. Ford mentioned that you might have to remove the brake line clip until the alignment was complete.

Top View

Bottom View

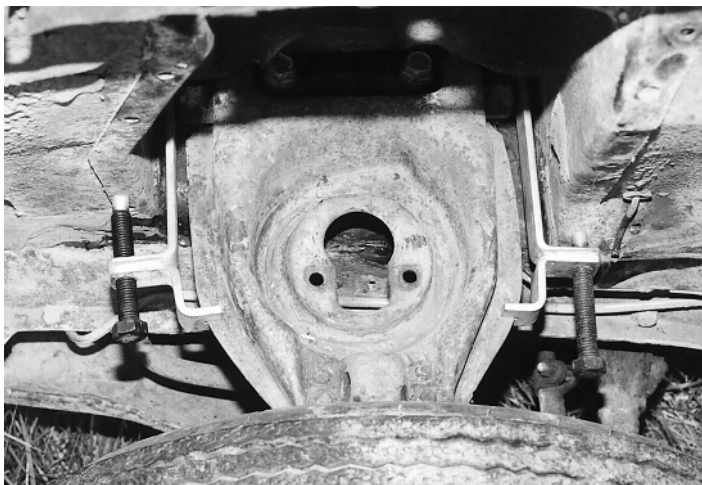
In essence, the VIM tool hugs the inner shaft bushings and has a slot that fits over the A-frame edge. The ends for around the bushing are curved to form a cradle. Two coarse-threaded bolts are used to effect the alignment. What I liked about the tool was that the screw pads were against the shock tower sheet metal, which is where the sheet metal is double in thickness.
