GENERAL SERVICE BULLETIN

Paint And Bumper Concern Analysis

20-7081
04 August 2020

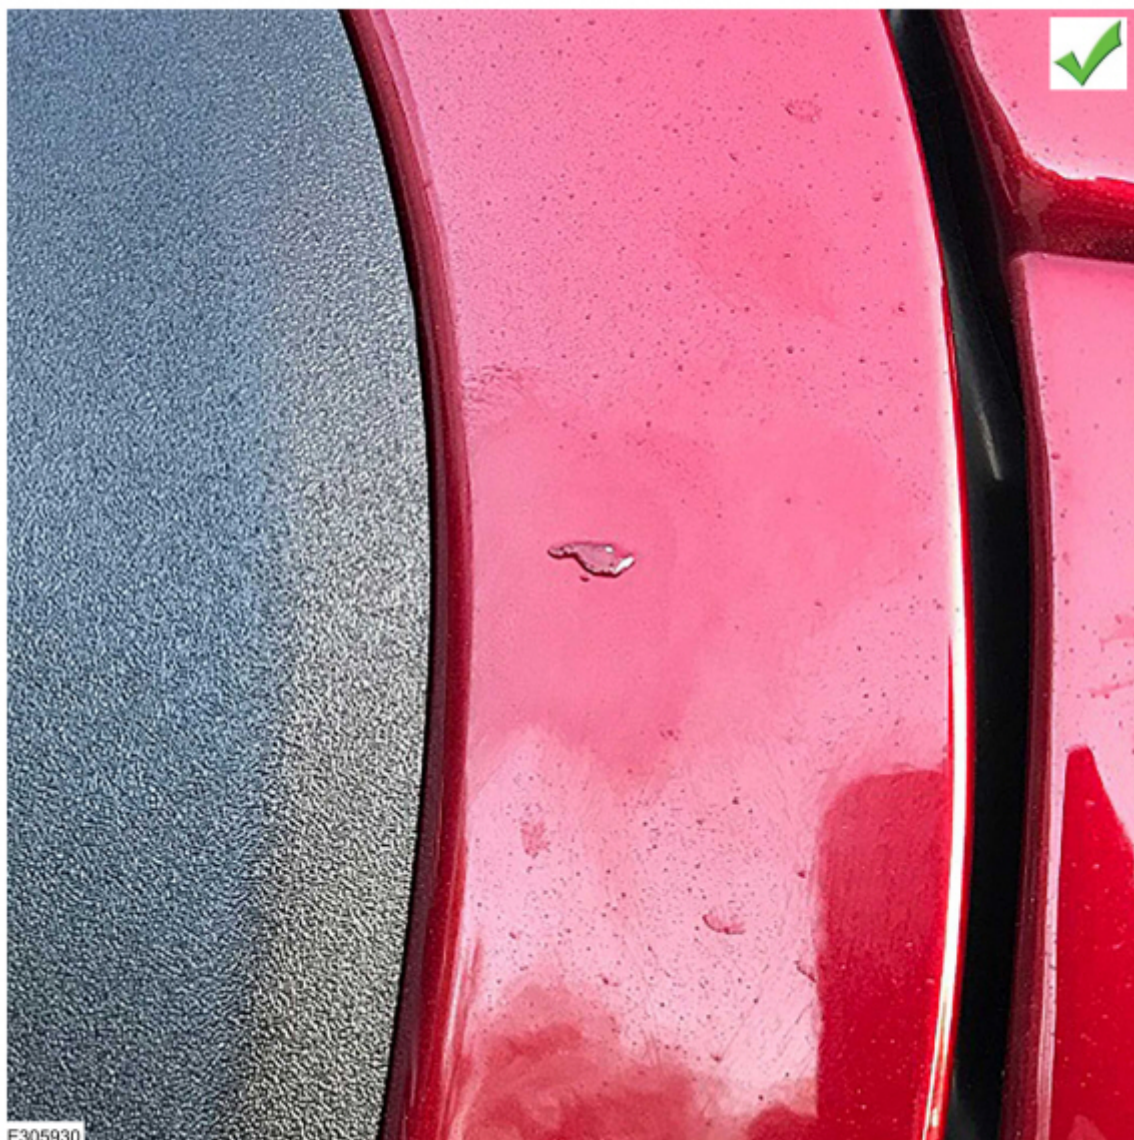
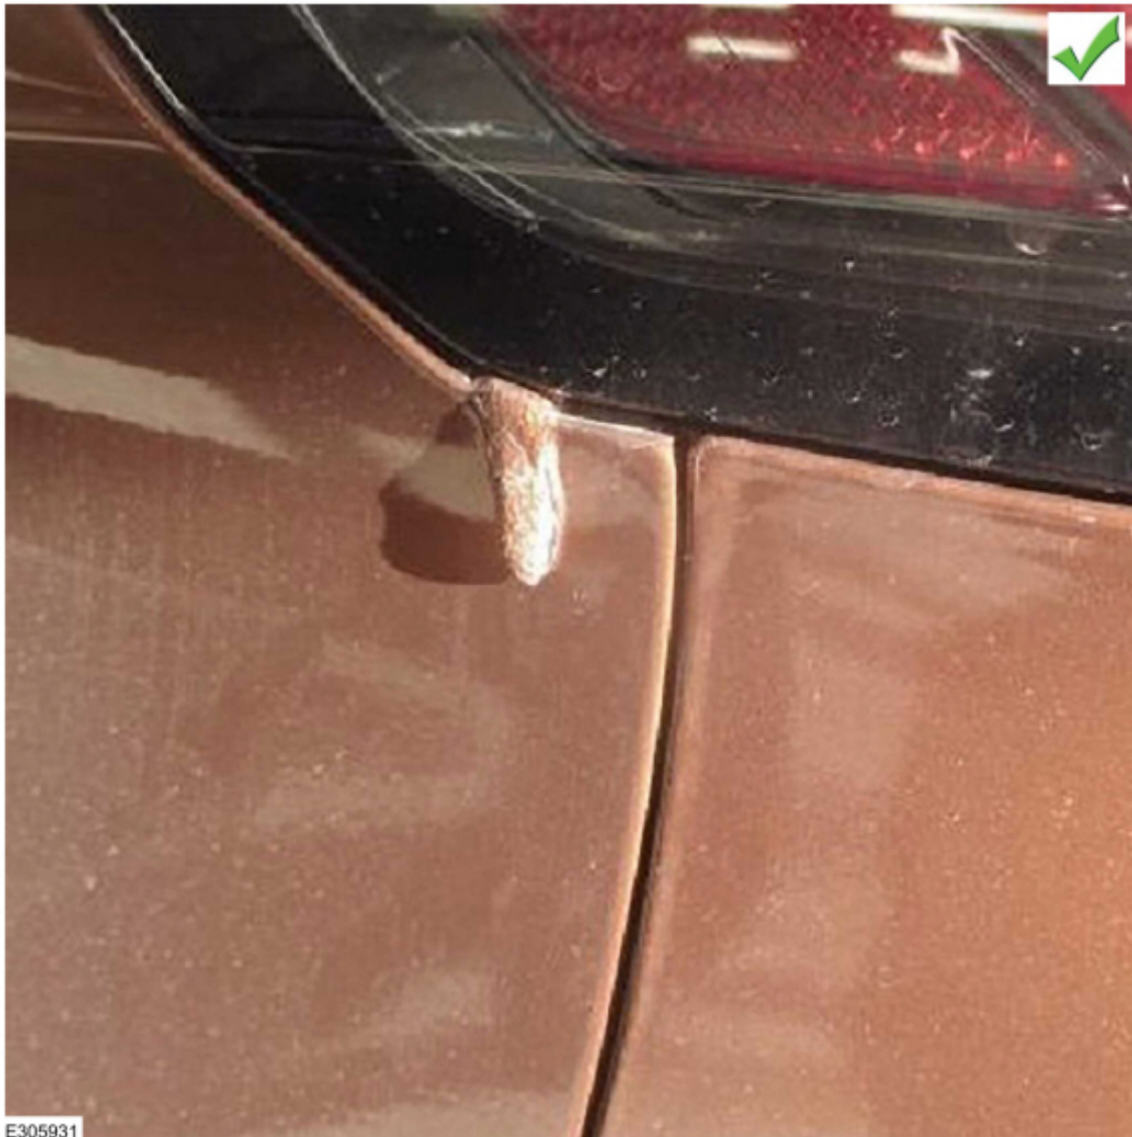
Dirt In The Finish (Warrantable)

Dirt, sealer, and other debris trapped during the factory finish application. (Figures 1-2)

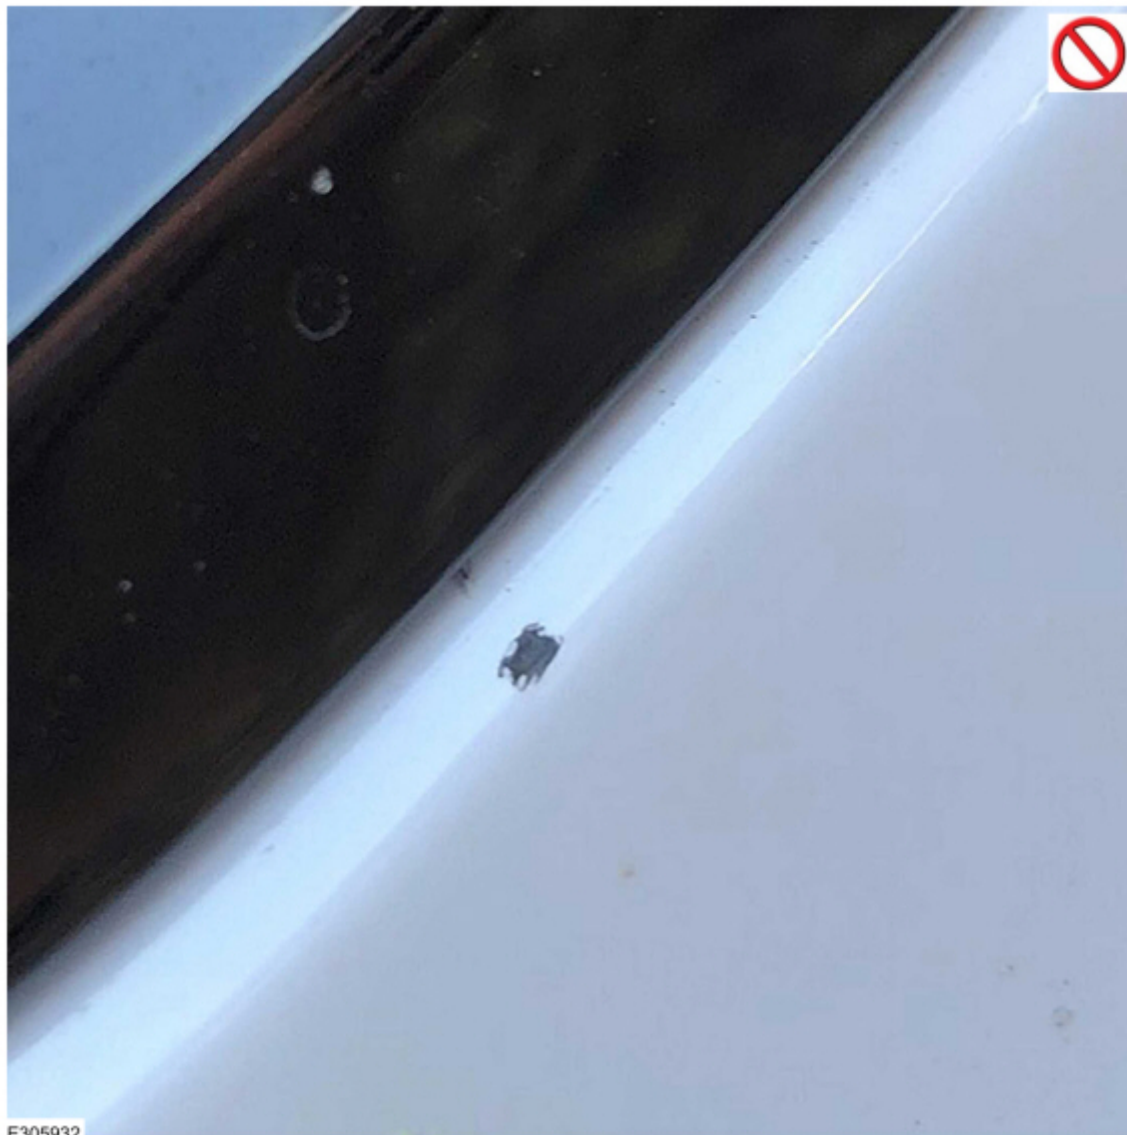
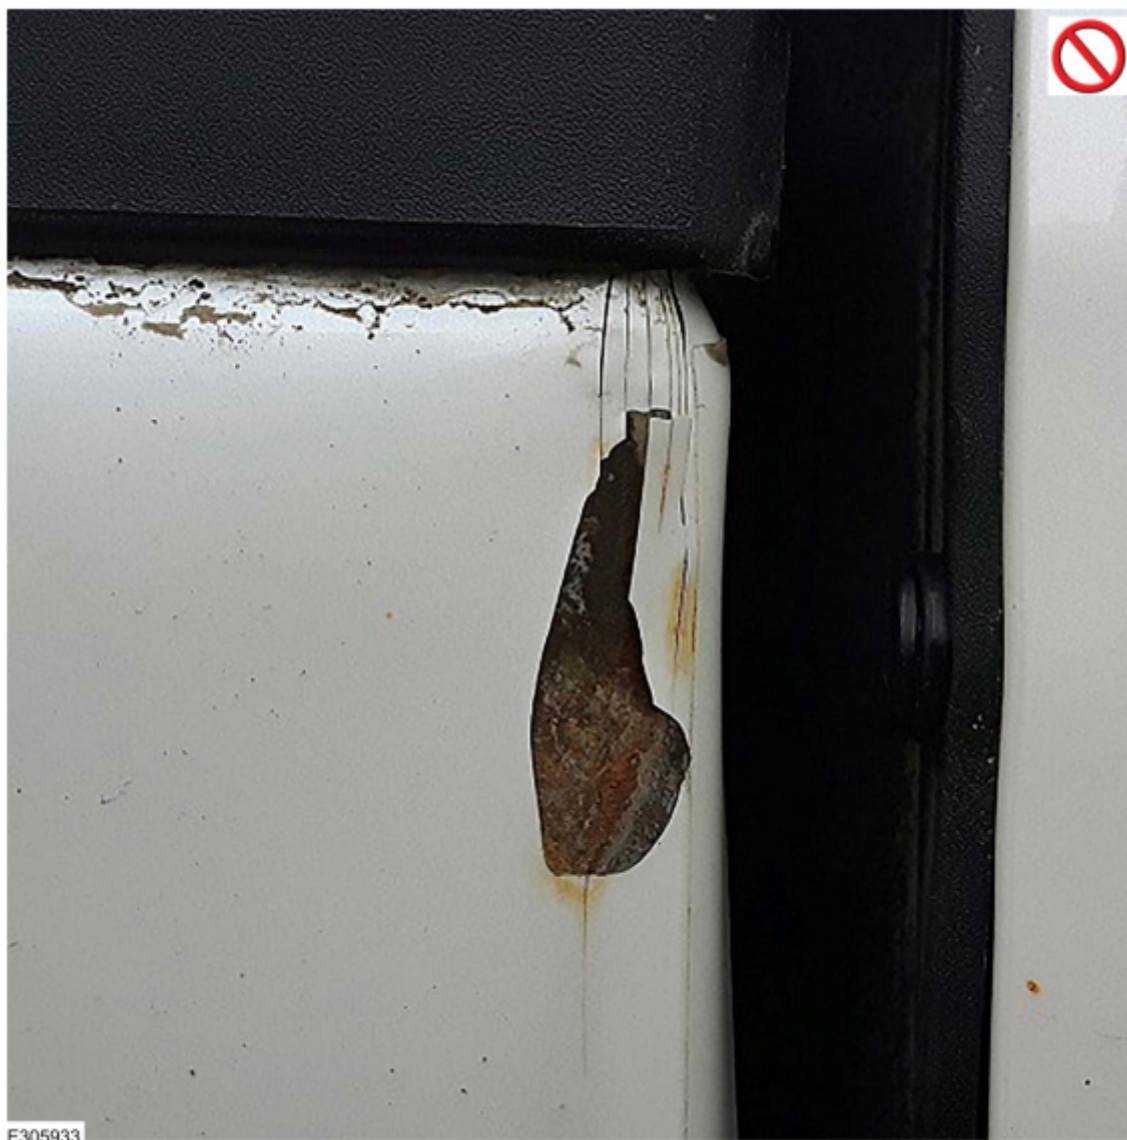
Impact (Chips, Dents) (Non-warrantable)

Impact damage causing removed finish, substrate damage, and jagged edges. (Figures 3-4)

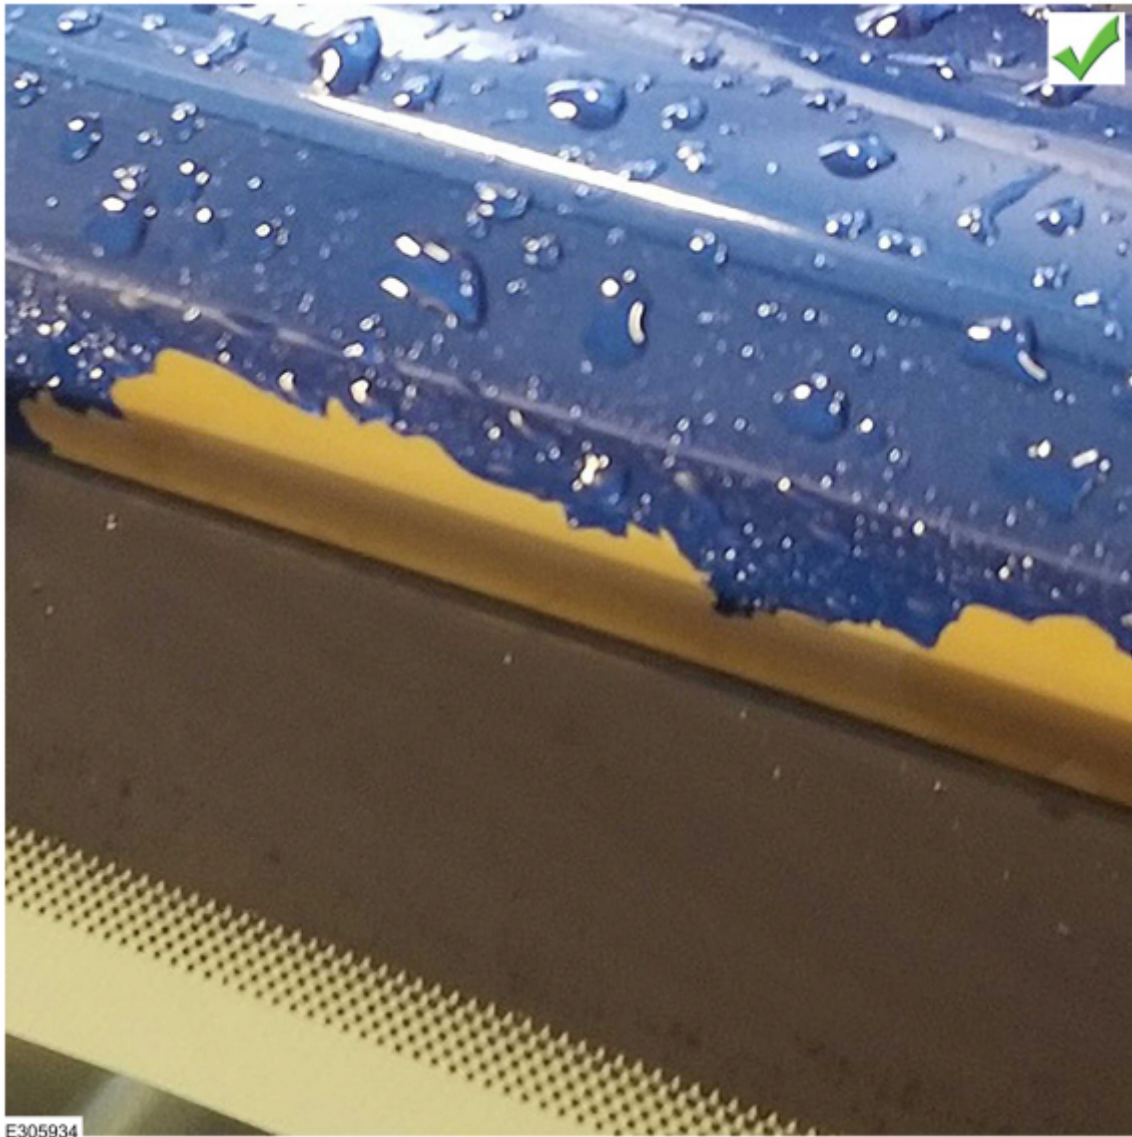
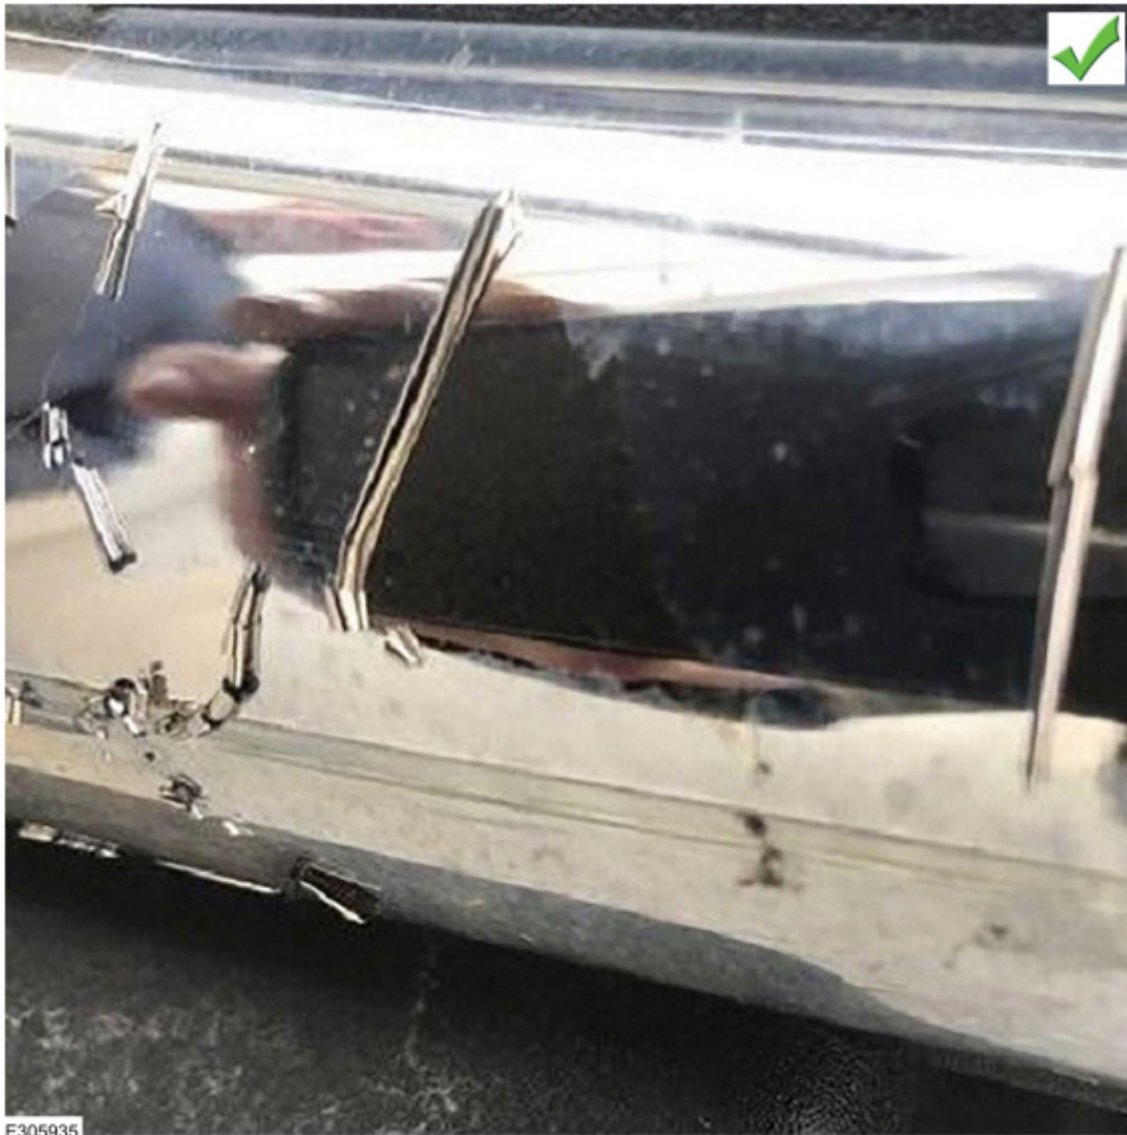
Peeling (Warrantable)

Peeling (without damage) to indicate an adhesion defect. (Figures 5-6)

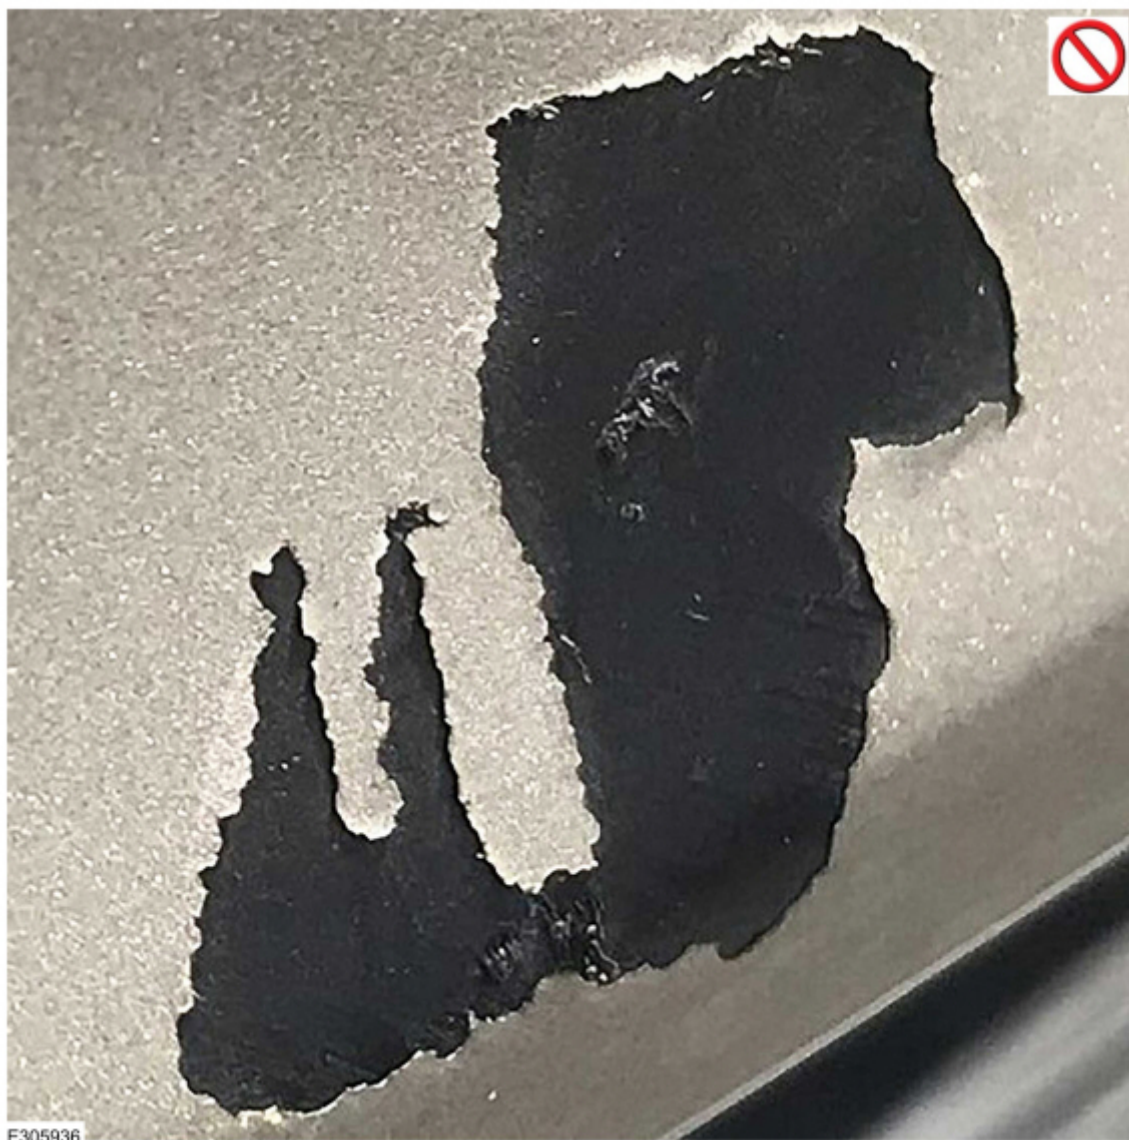
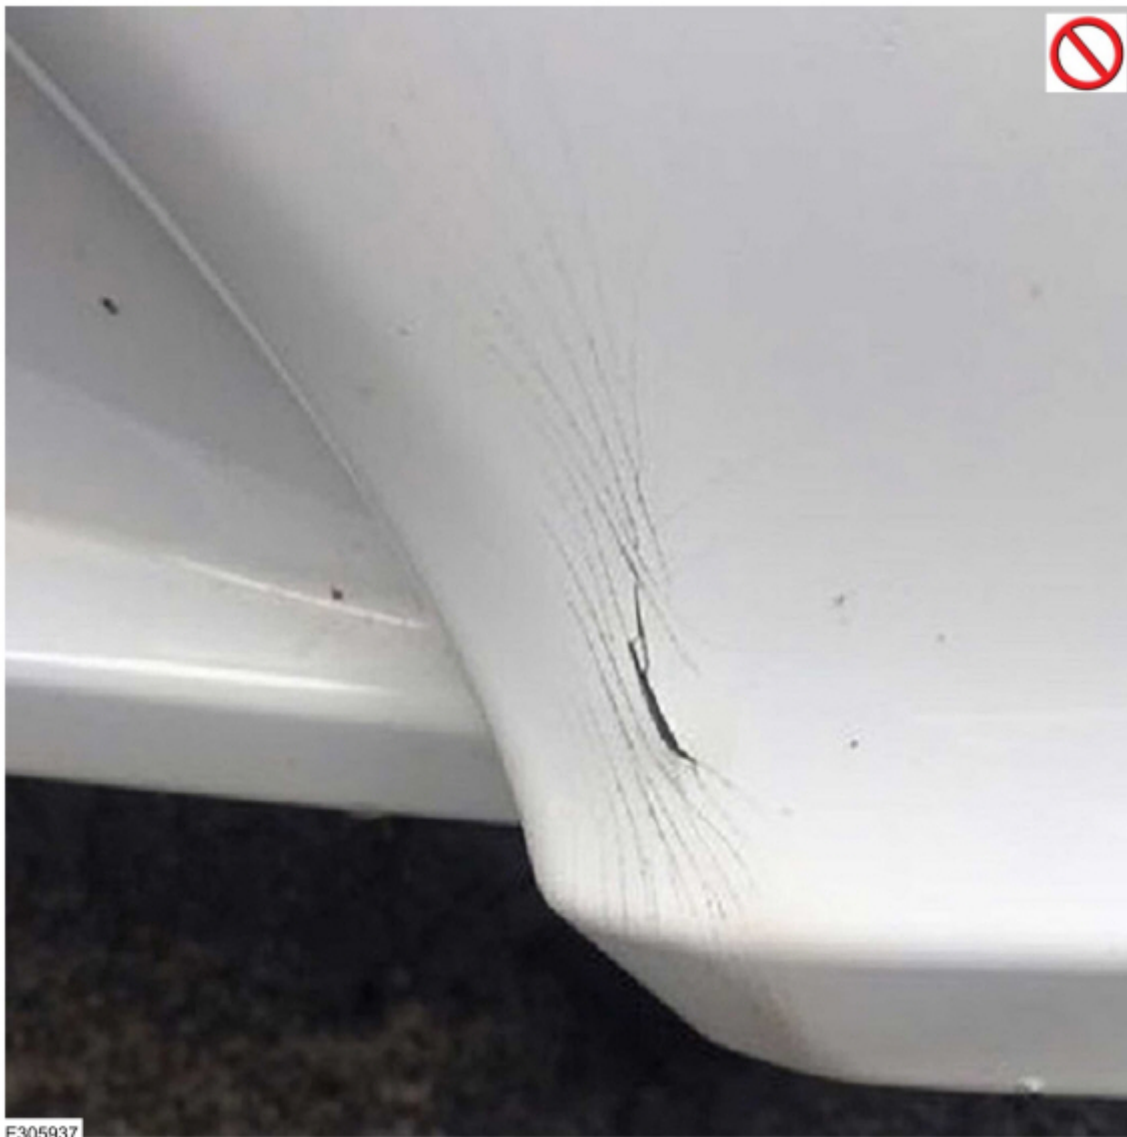
Peeling/Cracking Paint (With Damage) (Non-warrantable)

Peeling or cracks occur from stress due to impact or flexing of the substrate. (Figures 7-8)

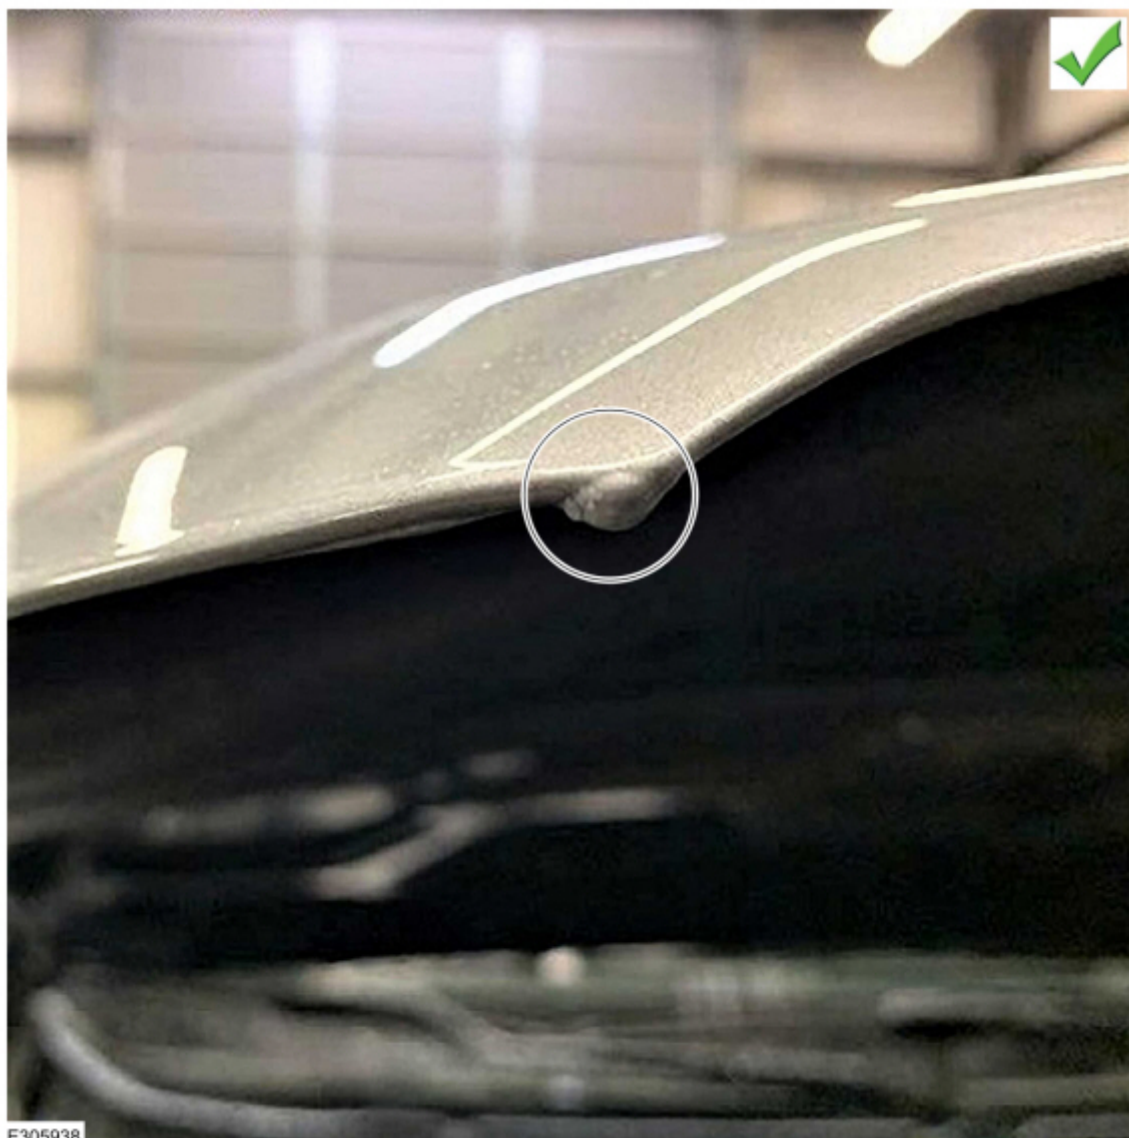
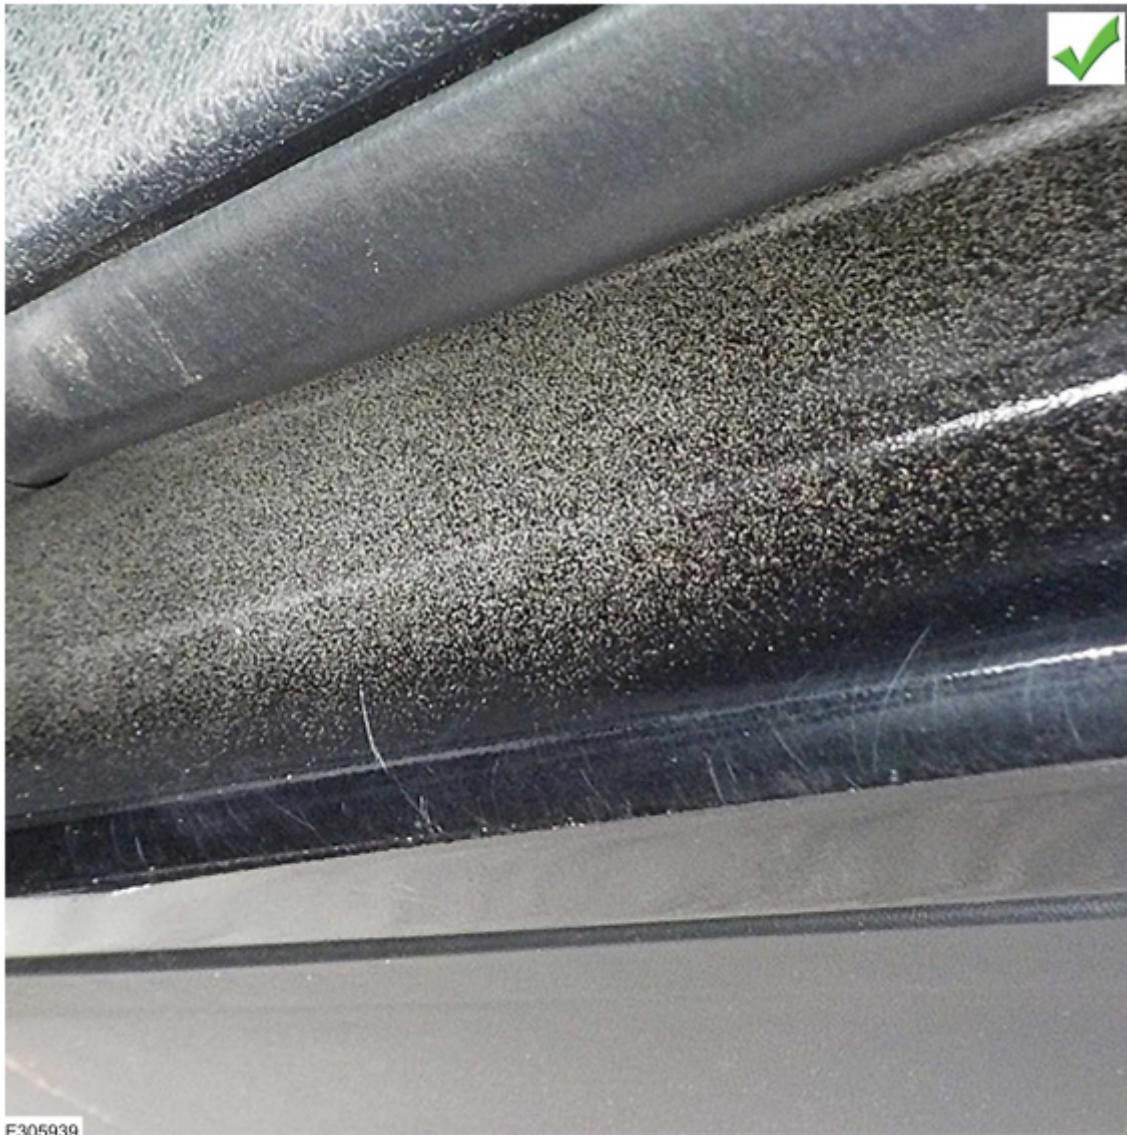
Runs/Thin Paint (Warrantable)

Causes include excessive or lack of material. (Figures 9-10)

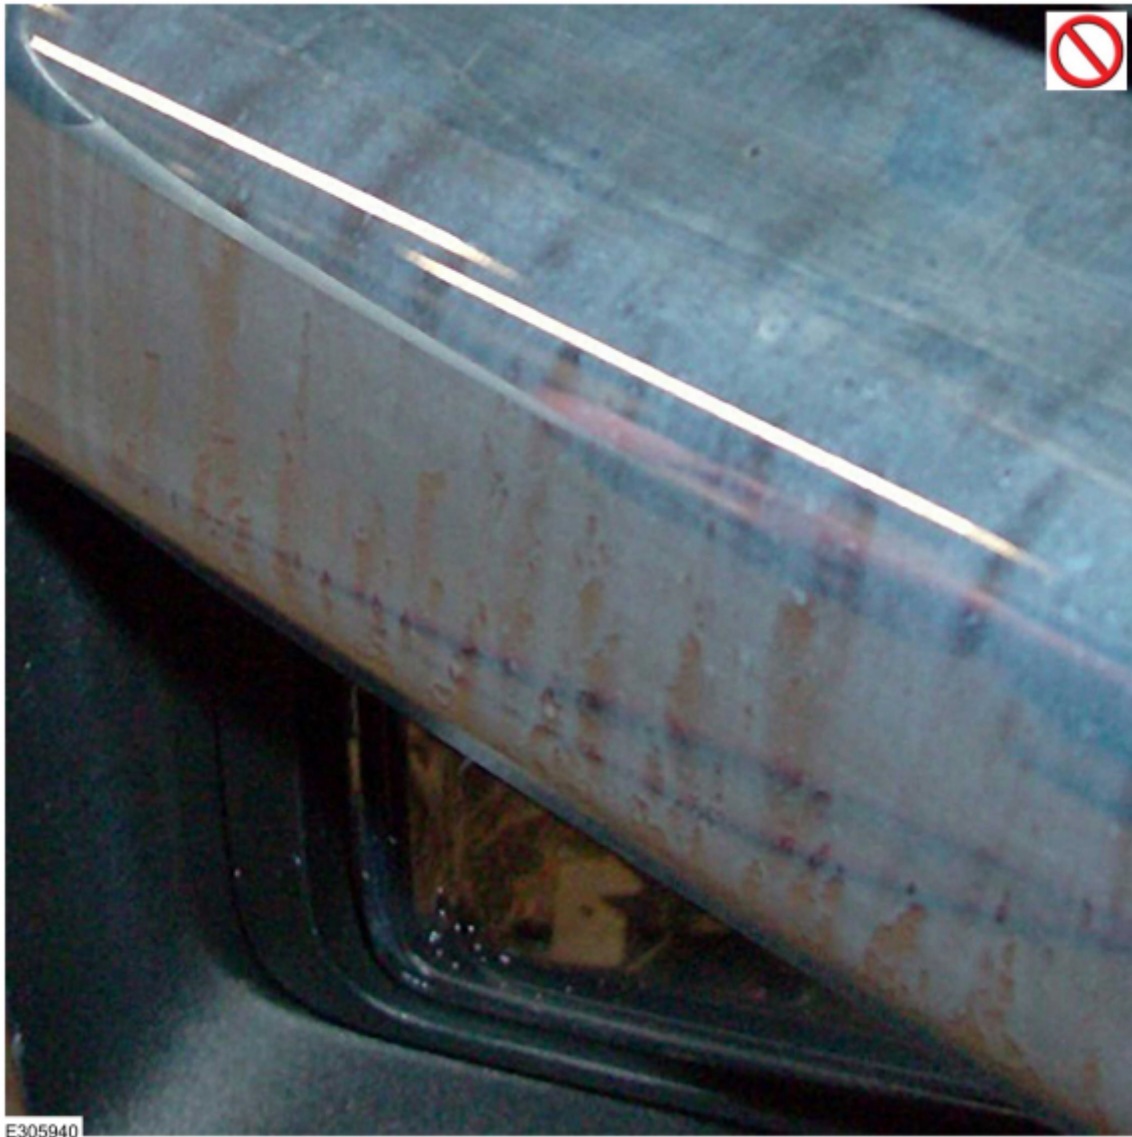
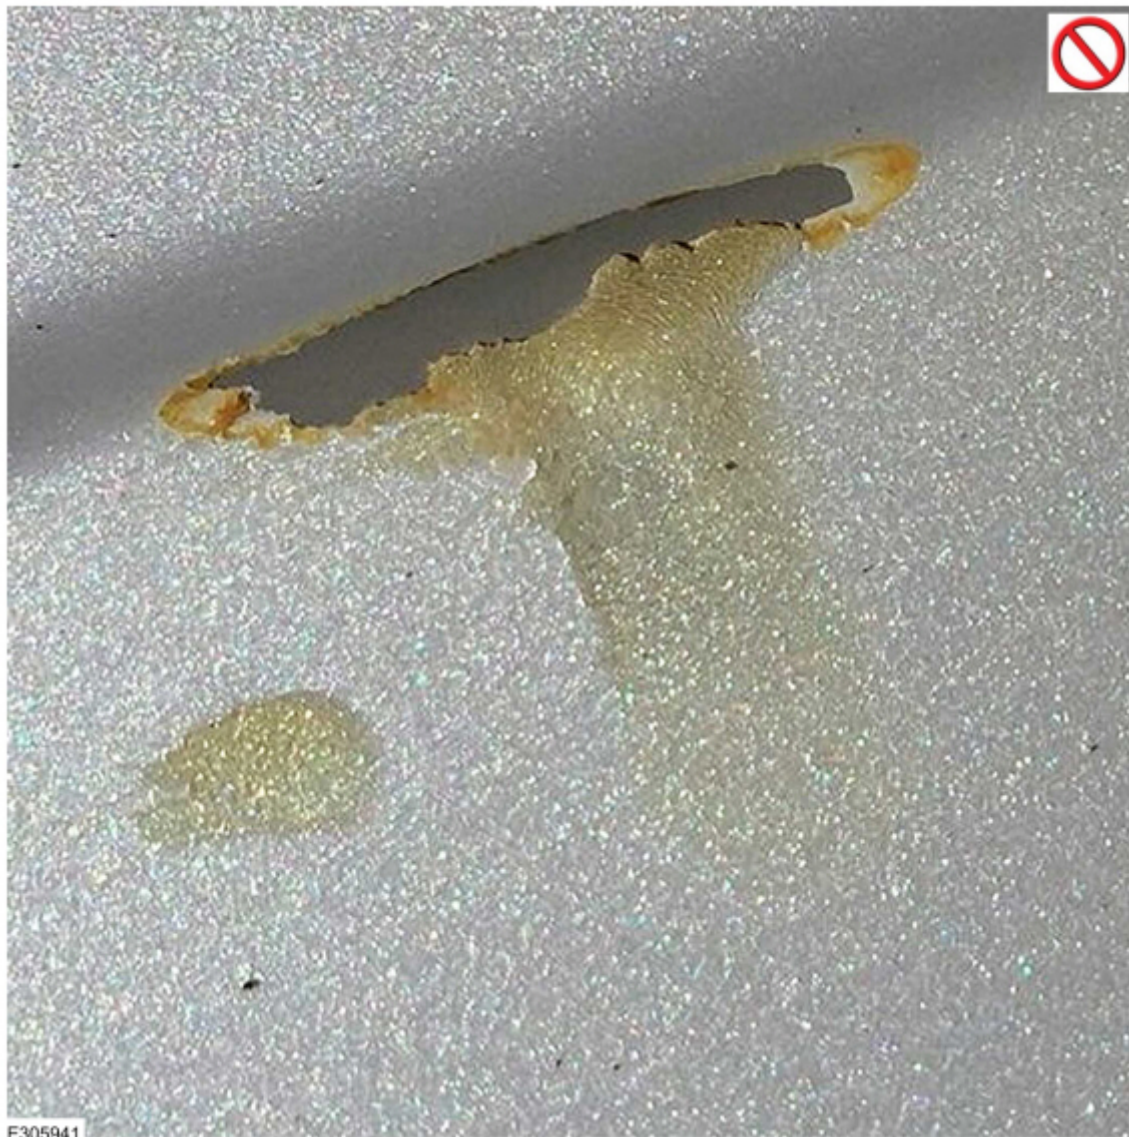
Stains (Non-warrantable)

Stains may exhibit a drip pattern from abrasive liquids. Etching cannot be felt and will appear dull. (Figures 11-12)

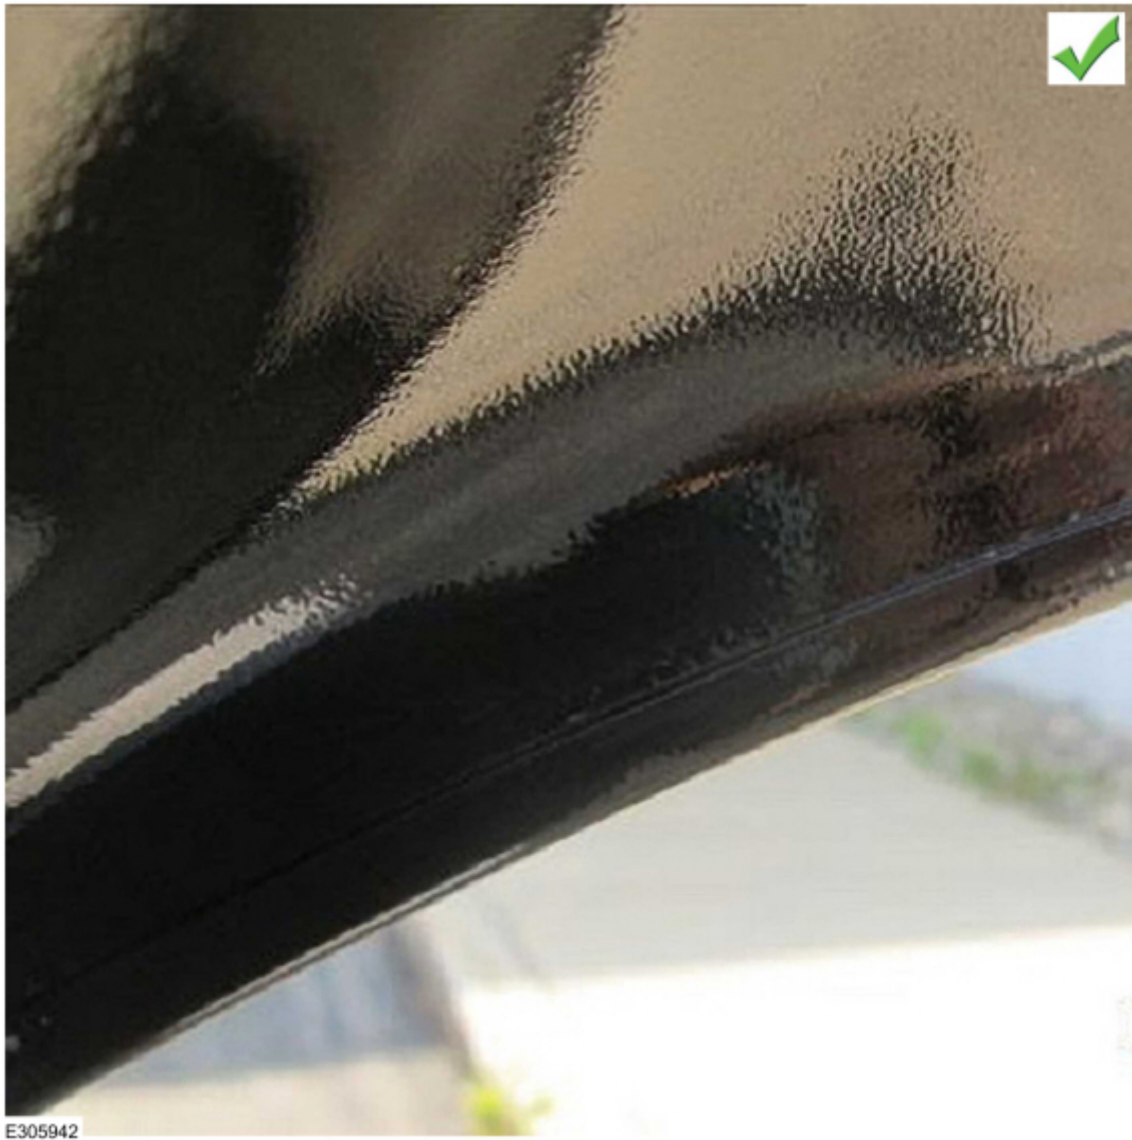
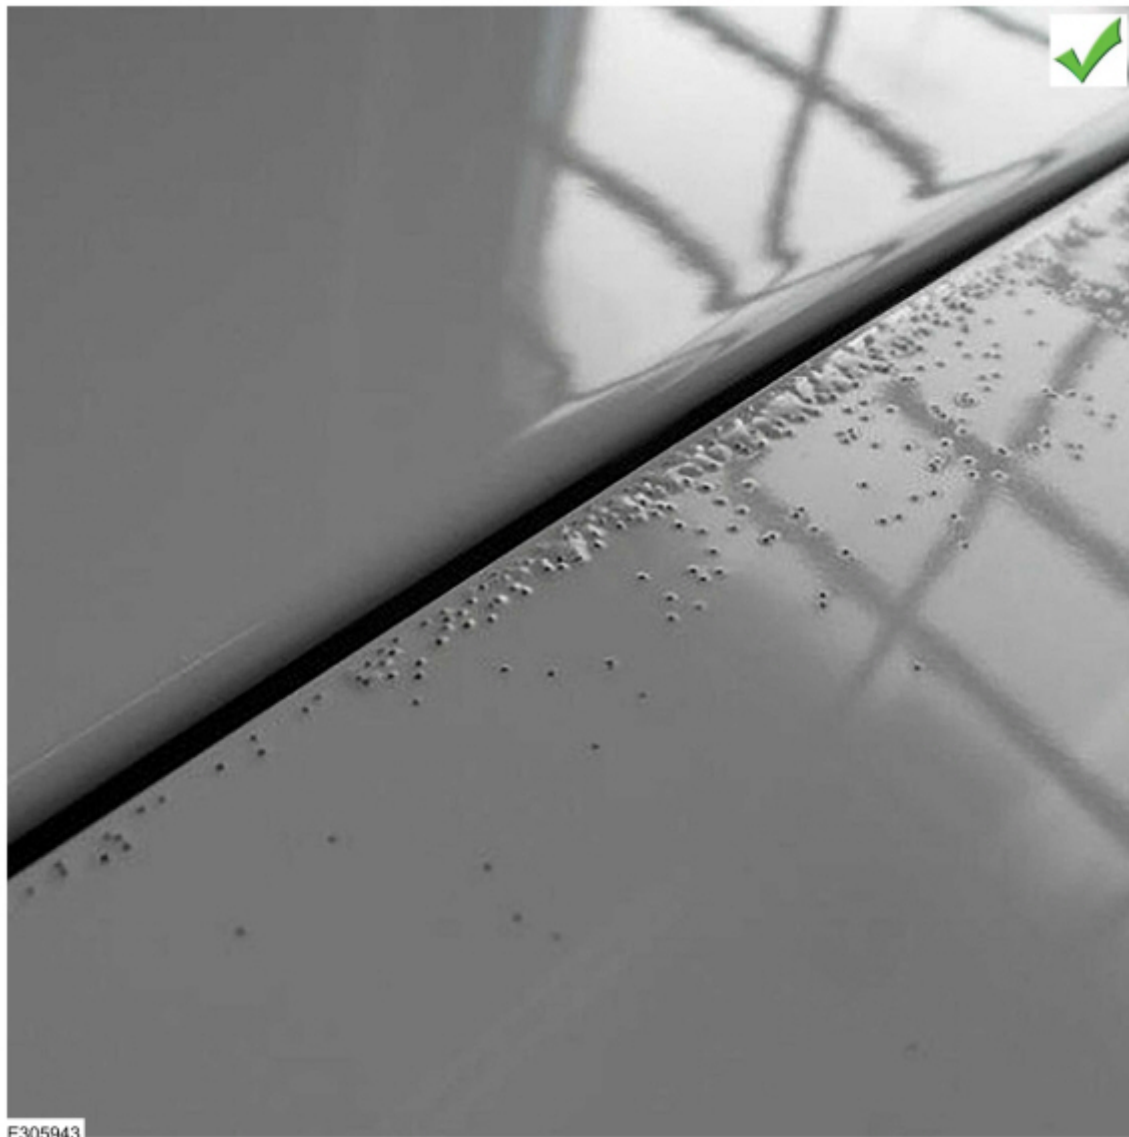
Orange Peel, Popping (Warrantable)

Small texture differences best seen in a reflection of light. (Figures 13-14)

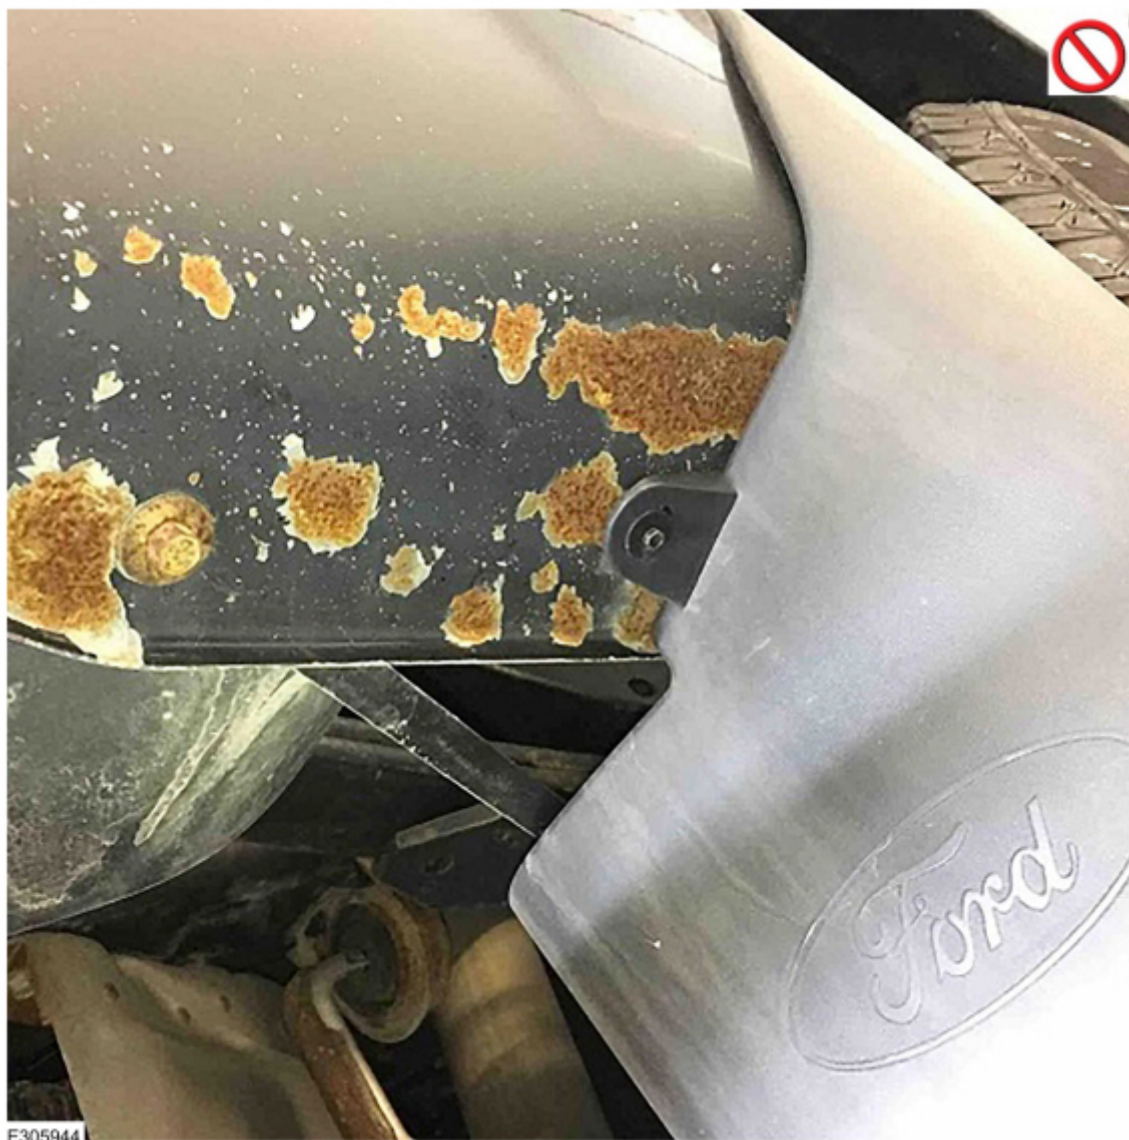
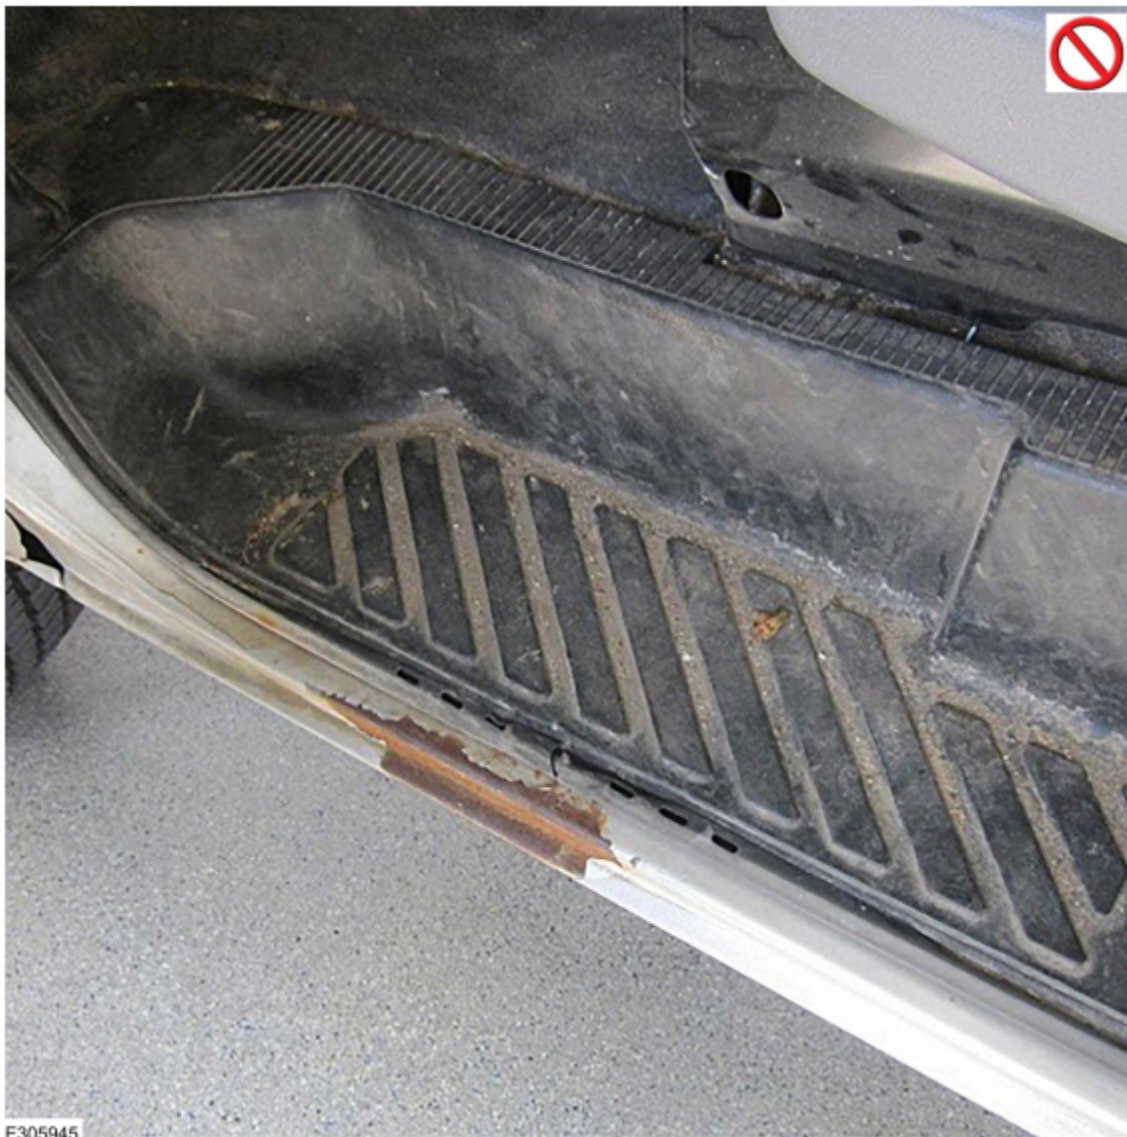
Abrasion, Wear (Non-warrantable)

Impact and abrasion. (Figures 15-16)

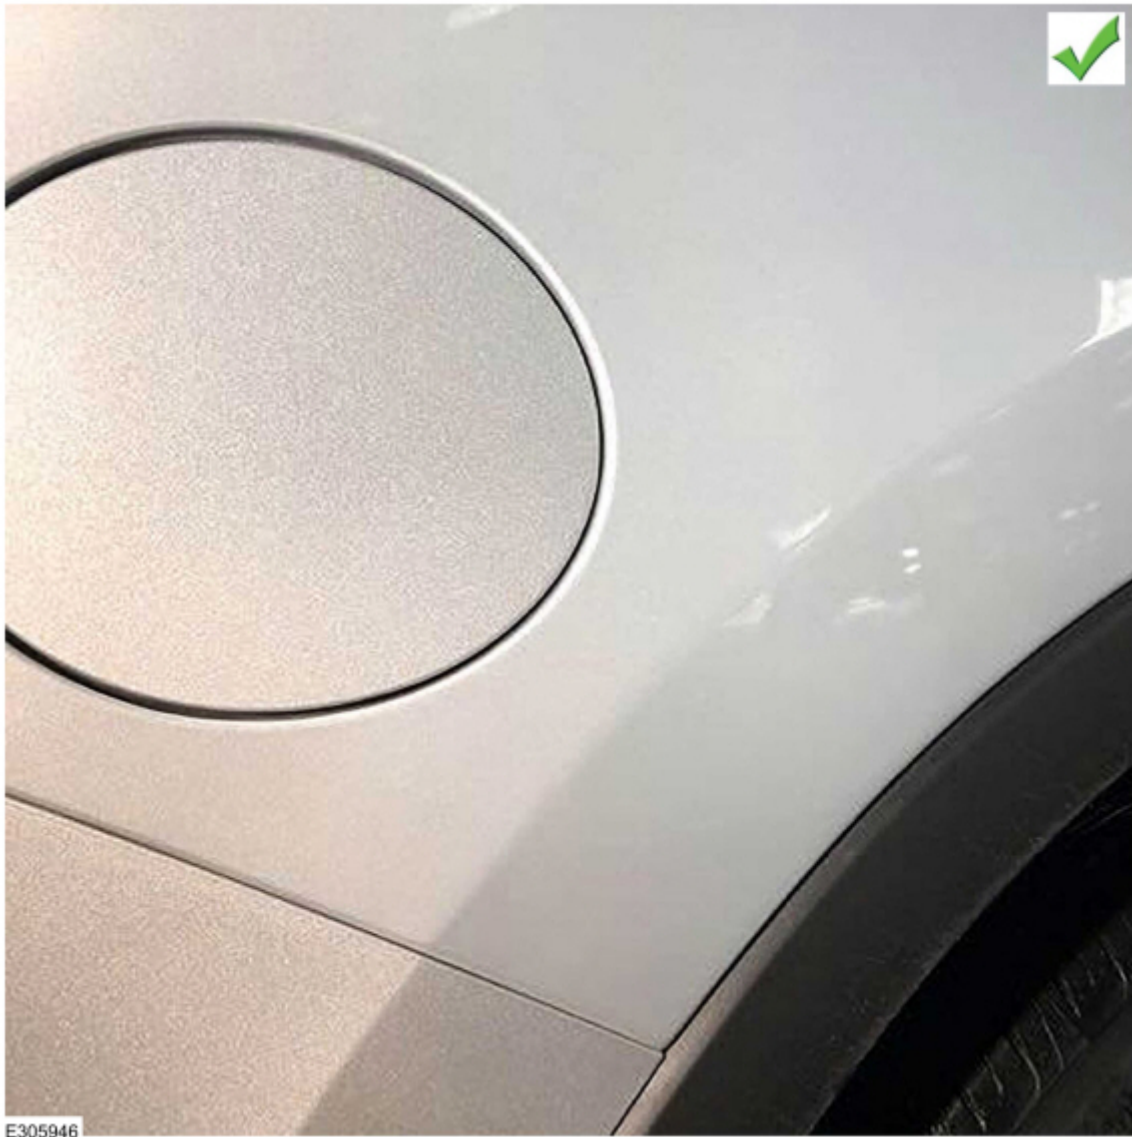
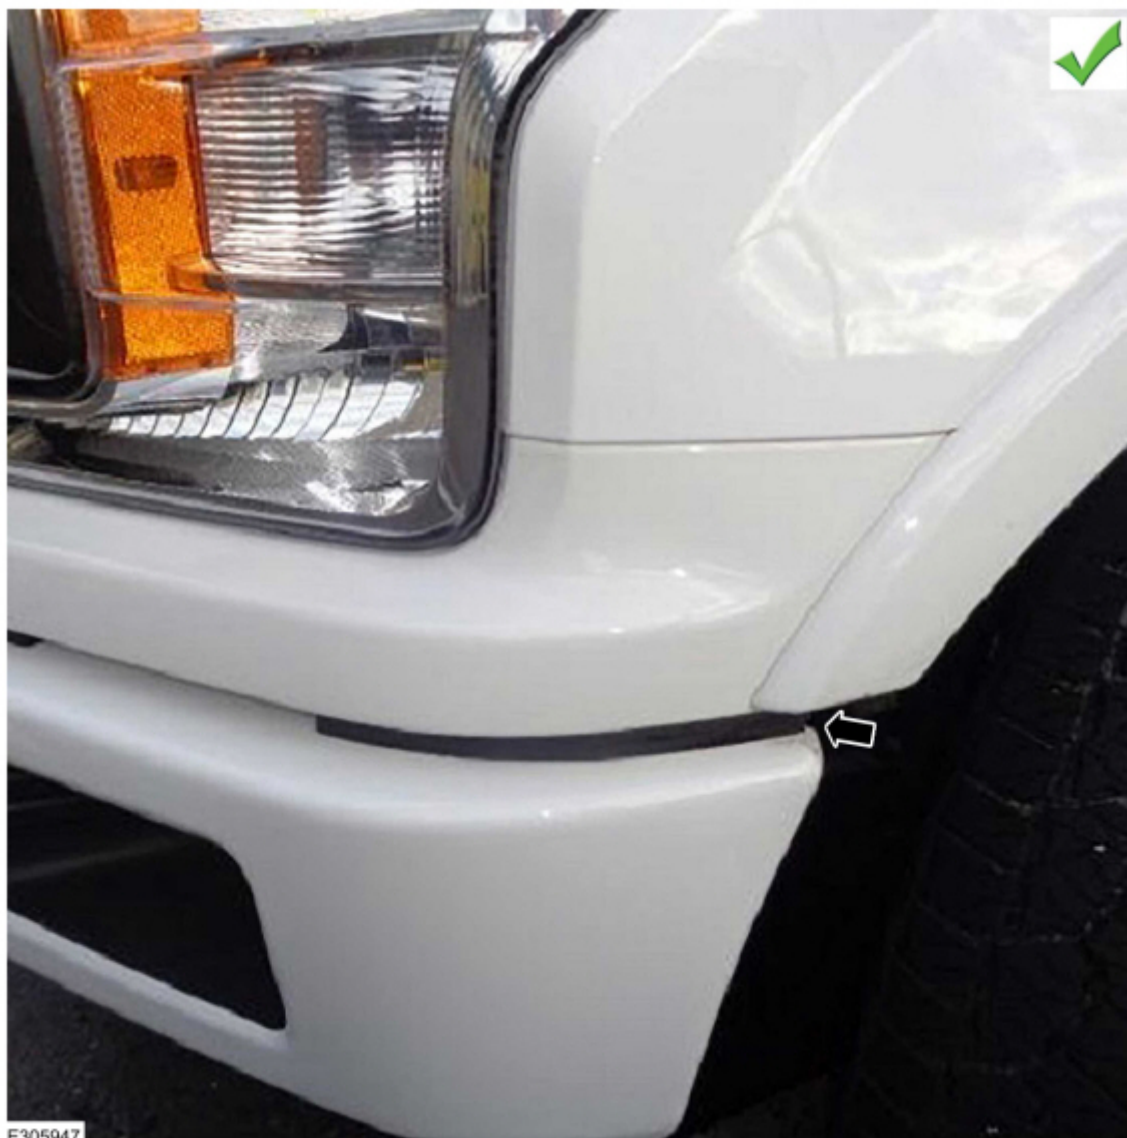
Paint Color Variation (Warrantable)

Normal variations are seen with different substrates but color differences should not be noted from all angles. (Figures 17-18)
