GENERAL SERVICE BULLETIN

Paint And Bumper Concern Analysis

20-7081
04 August 2020

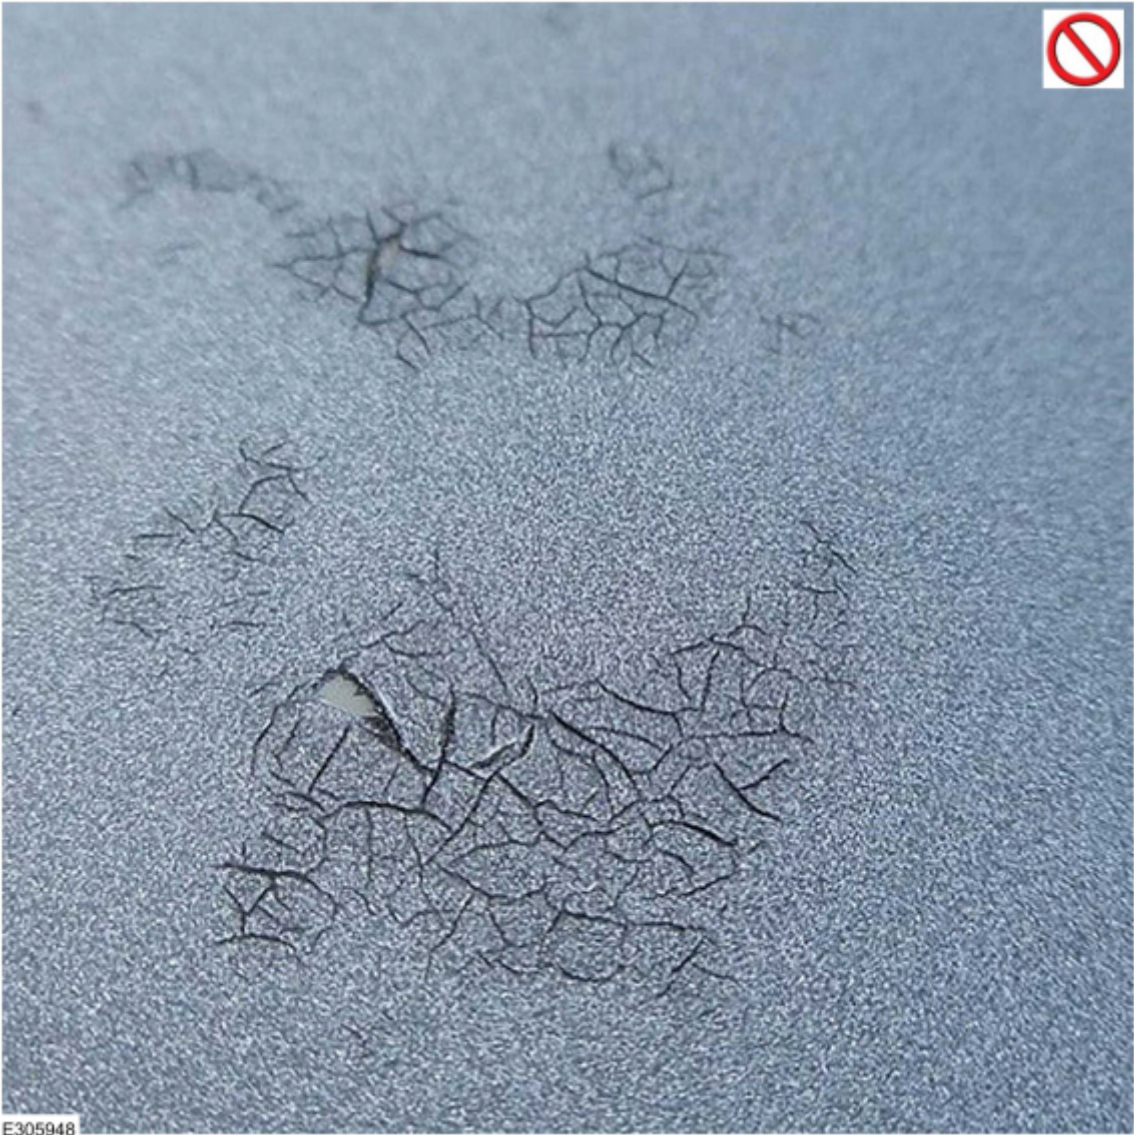
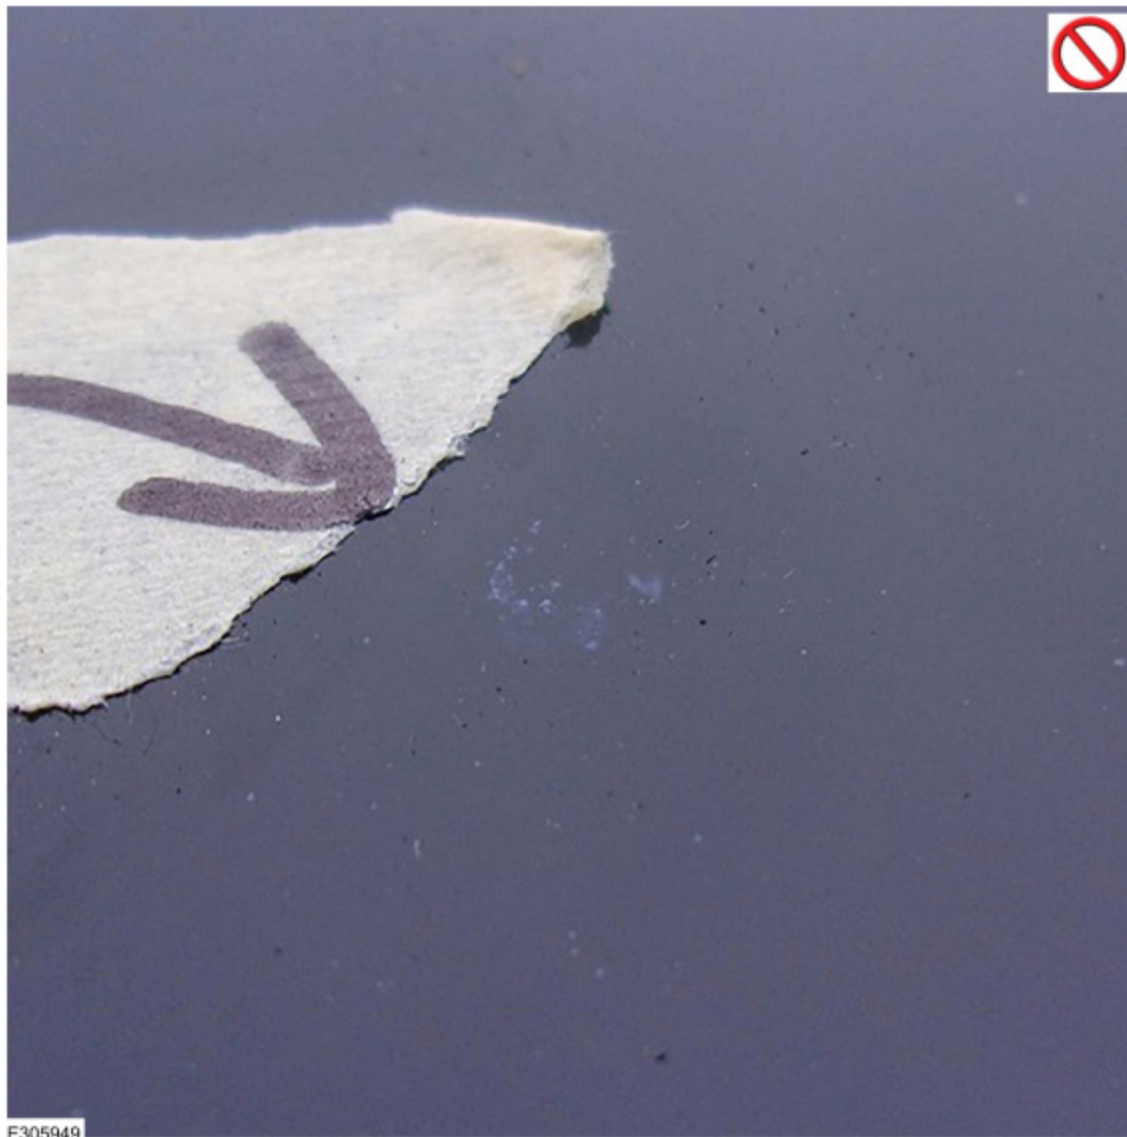
Etching From Abrasives Including Environmental (Non-warrantable)

Bird and bee droppings, tree sap. Etching (discolored) cannot be felt. Cracking/removed finish. (Figures 19-20)

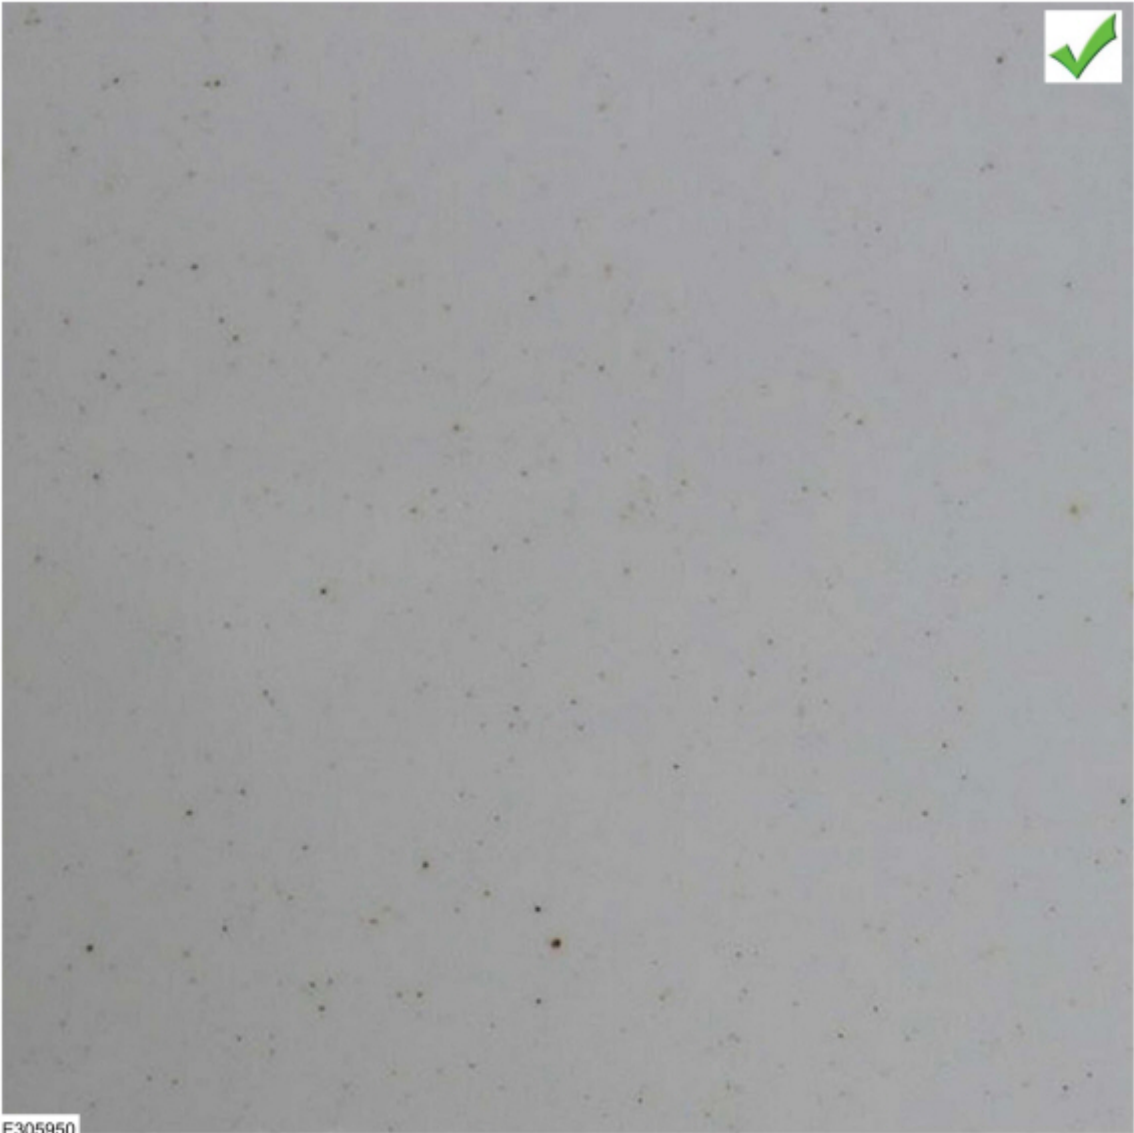
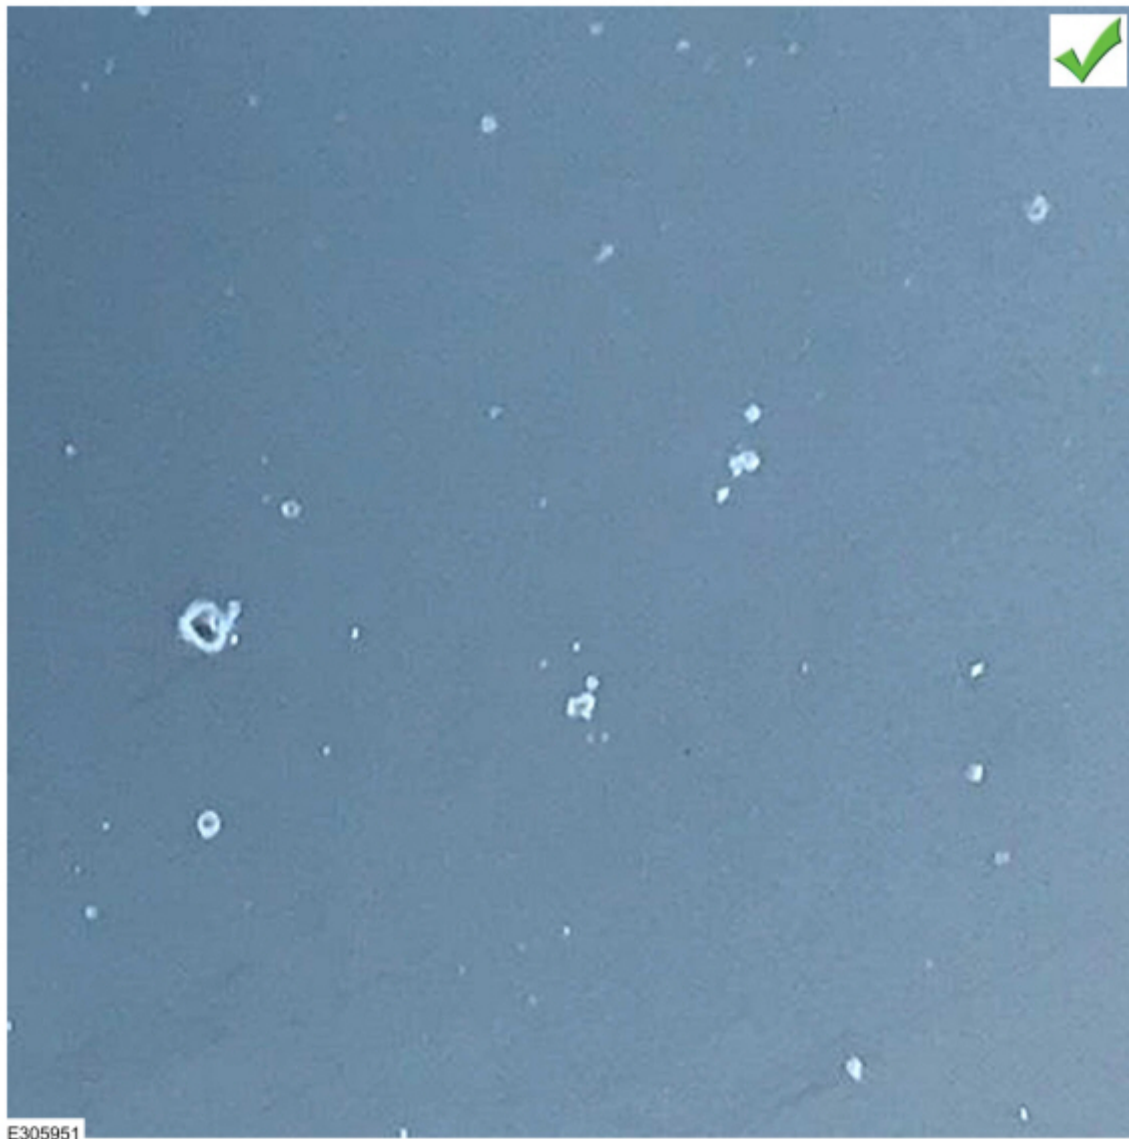
Environmental Fallout (Warrantable)

Not a paint defect. This will appear orange on lighter colors or white/blue on darker colors. Limited coverage is outlined in the Warranty and Policy Manual. (Figures 21-22)

Environmental damage can be removed by following the Acid/Alkaline Wash Decontamination Procedure detailed in section 501 of the Workshop Manual. Once the environmental damage is removed, buffing and polishing may be required.

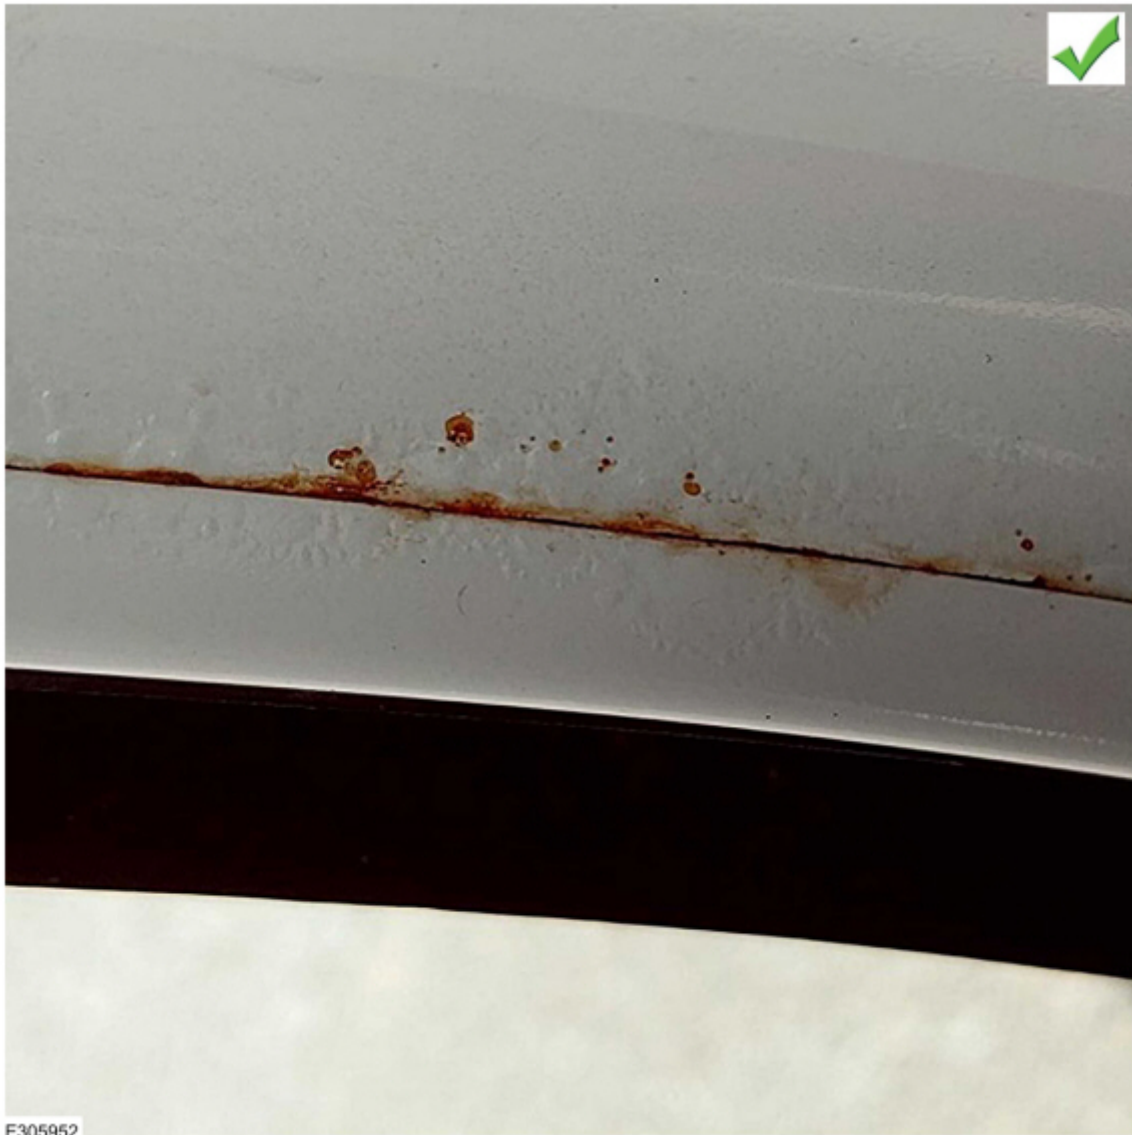
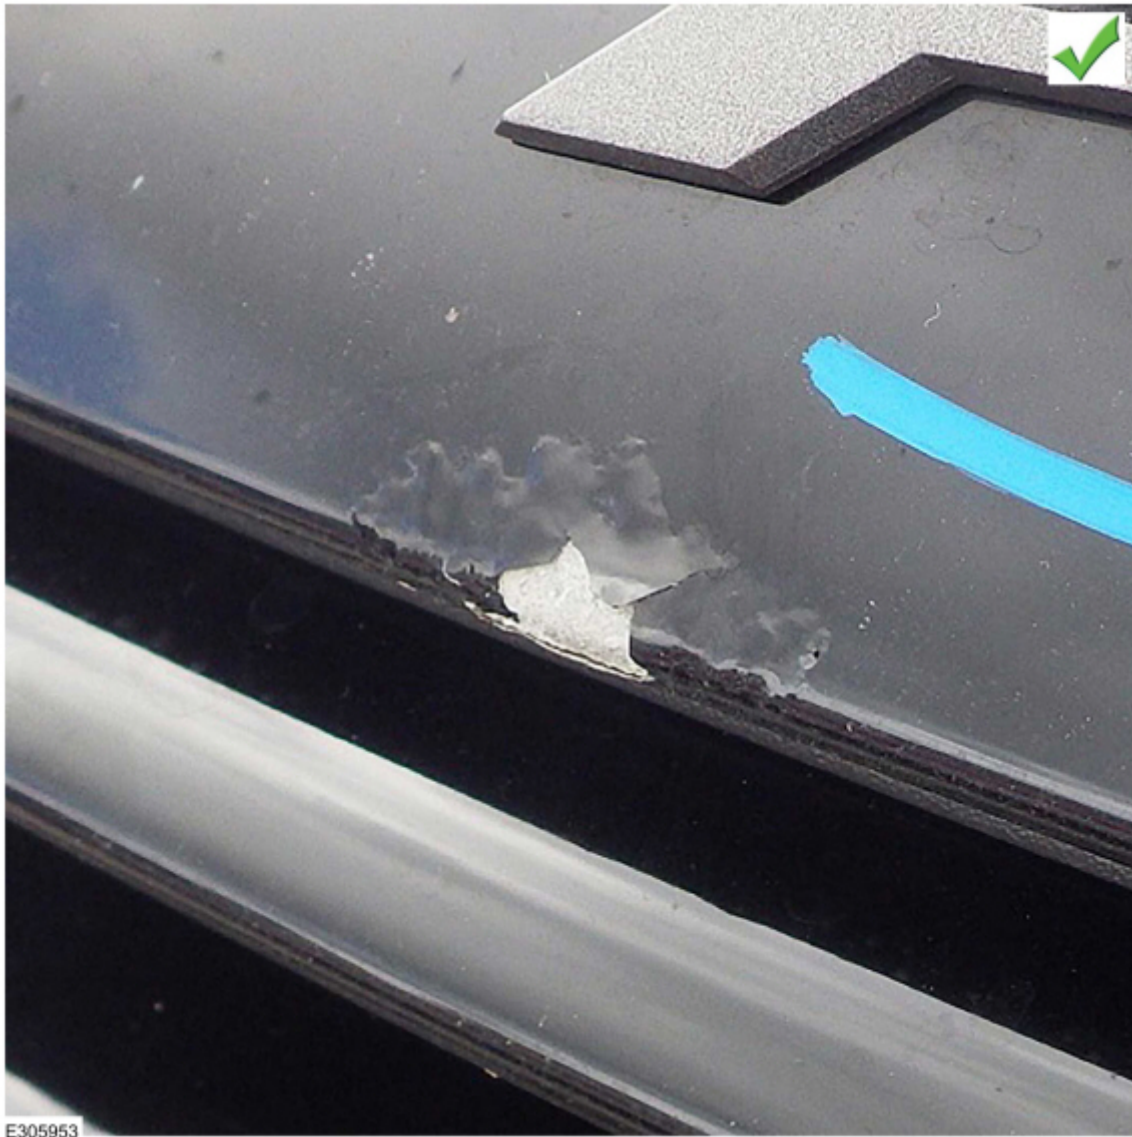
Corrosion (Warrantable)

Steel and aluminum corrosion shown in Figures 23 and 24. See the Warranty and Policy Manual for extended coverages.

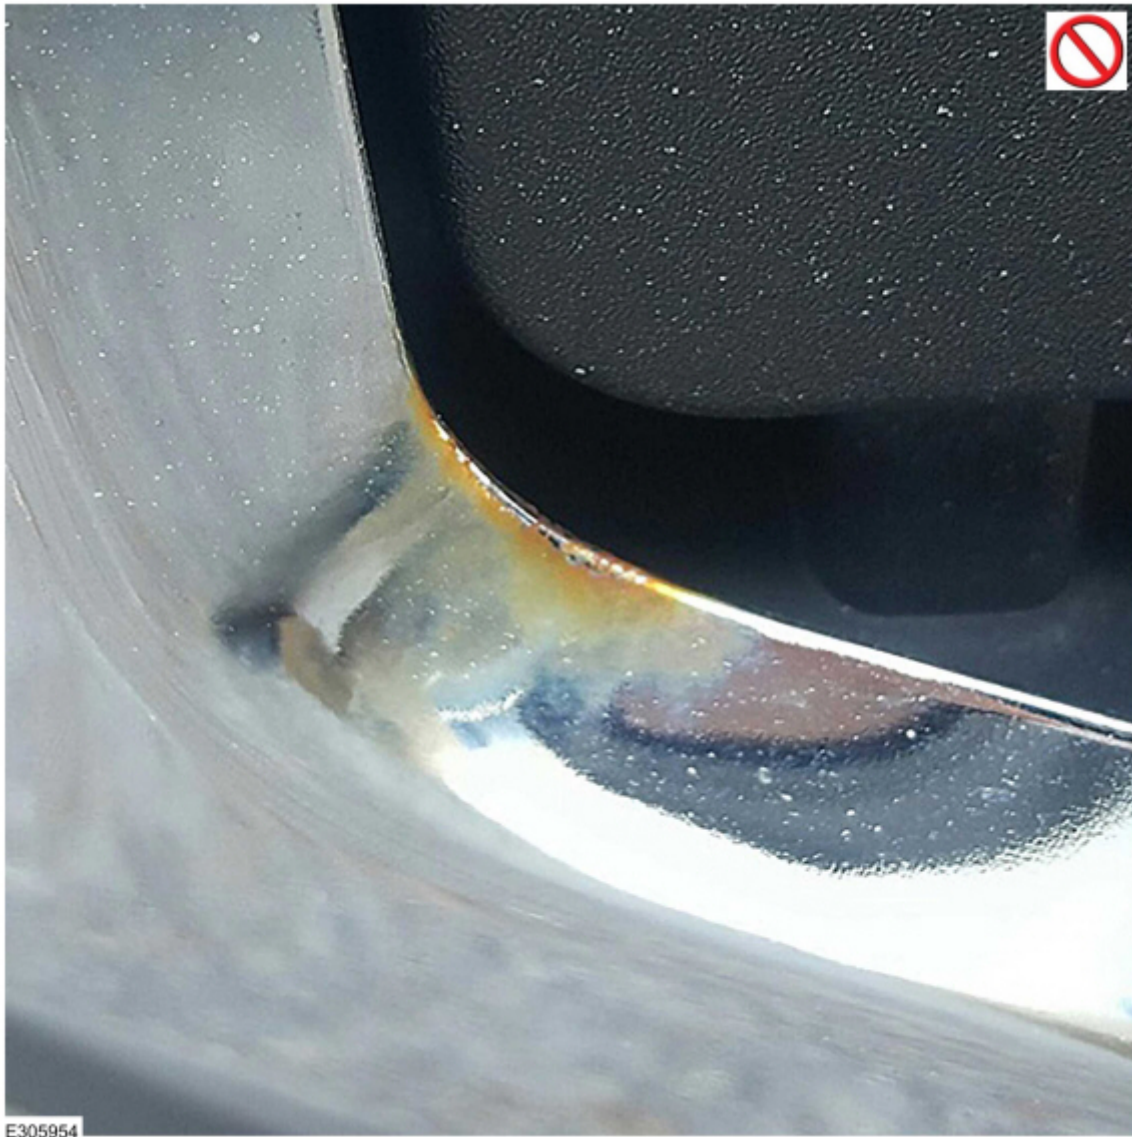
Figure 25

Corrosion (Non-warrantable)

Surface corrosion which can be removed with cleaning. (Figure 25)

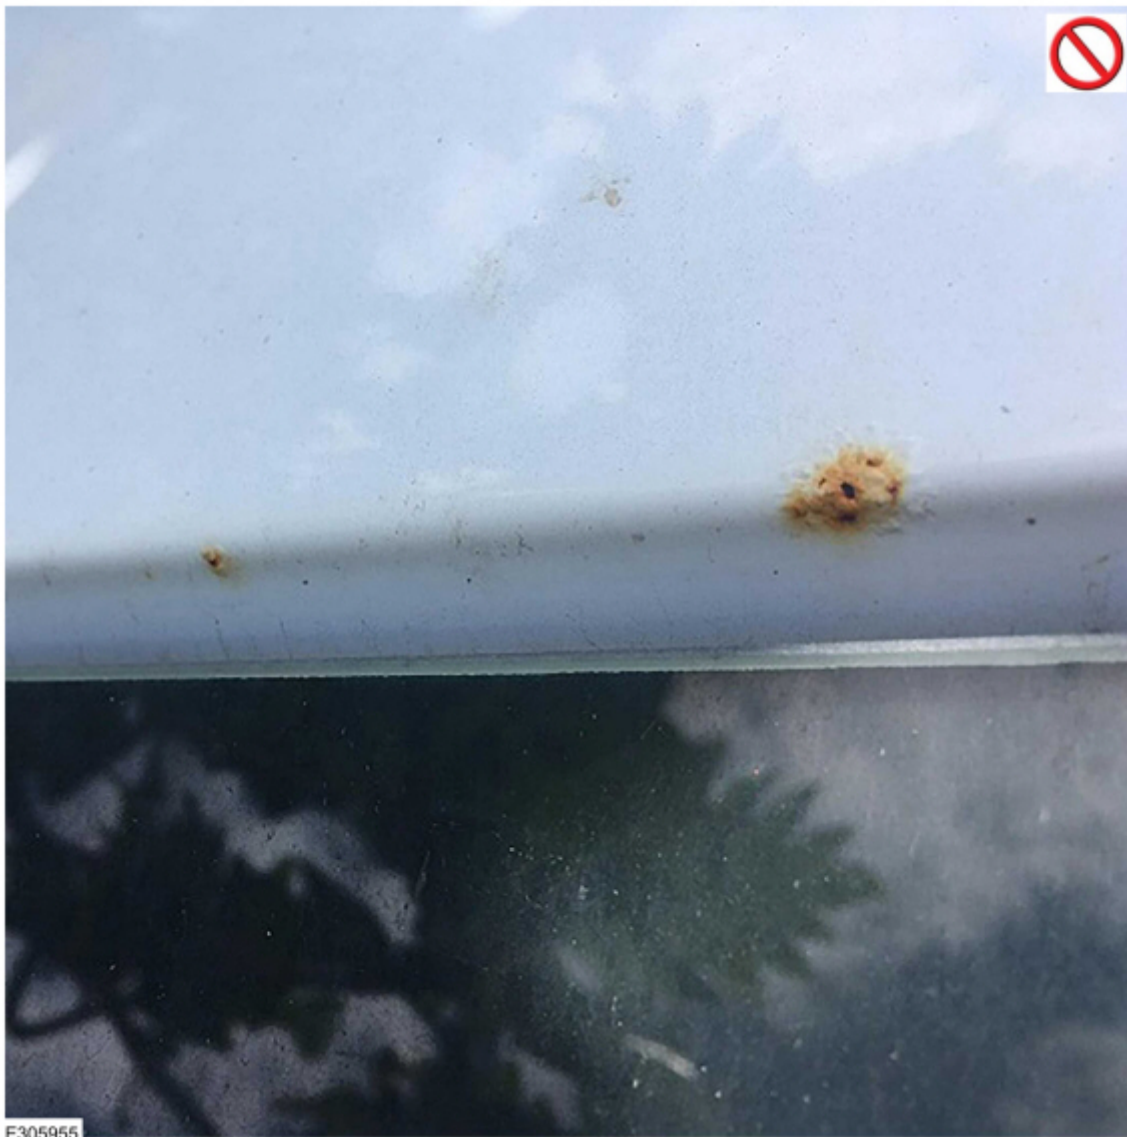
Figure 26

Corrosion caused by damage. (Figure 26)

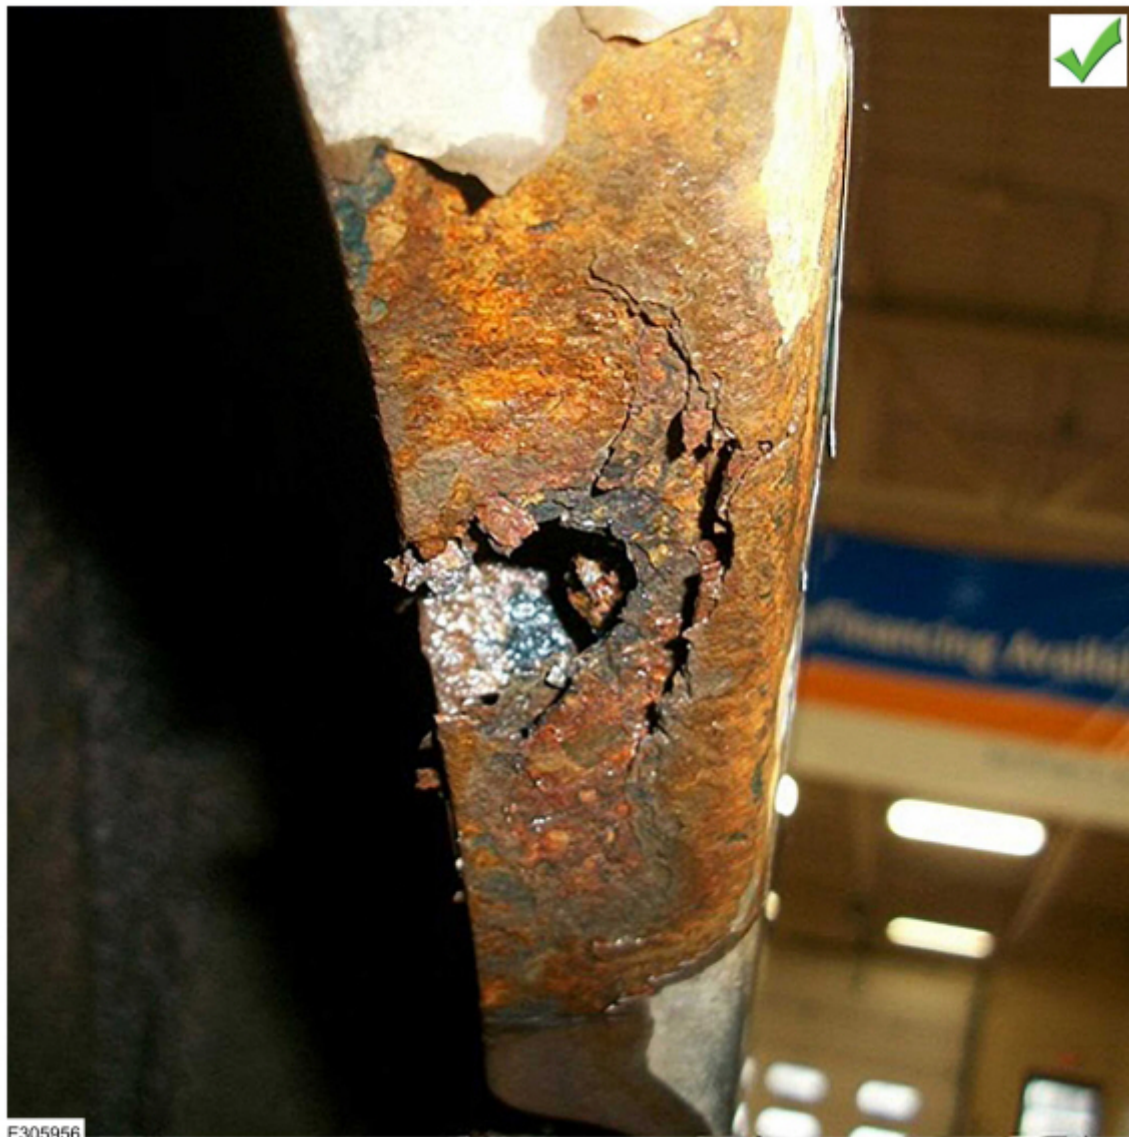
Figure 27

Rust Perforation (Warrantable)

Rust damage resulting in perforation (holes). (Figure 27)

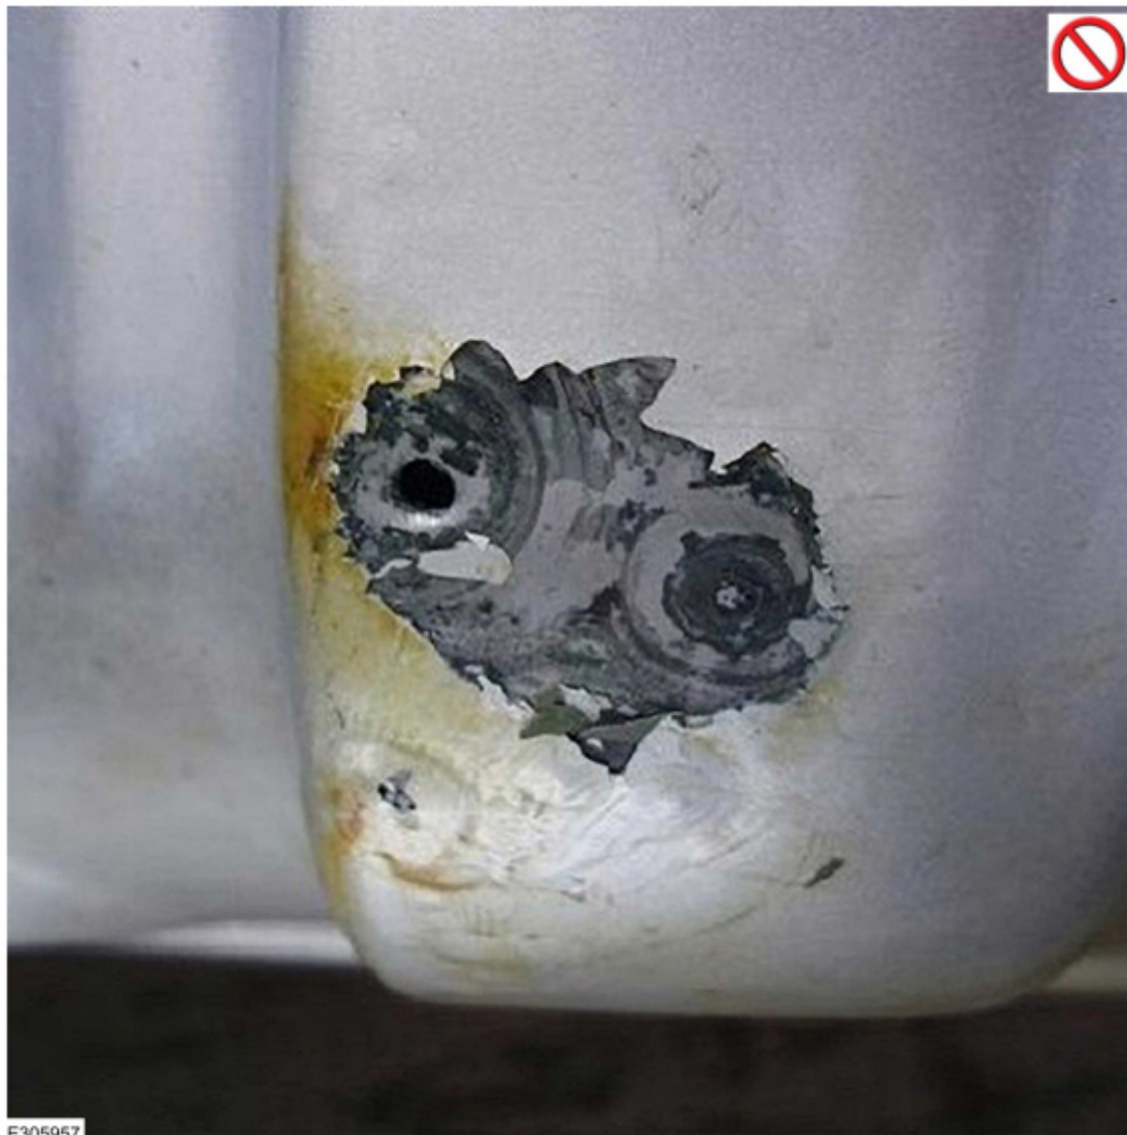
Figure 28

Mechanically Caused Perforation (Non-warrantable)

Corrosion must be naturally occurring. (Figure 28)

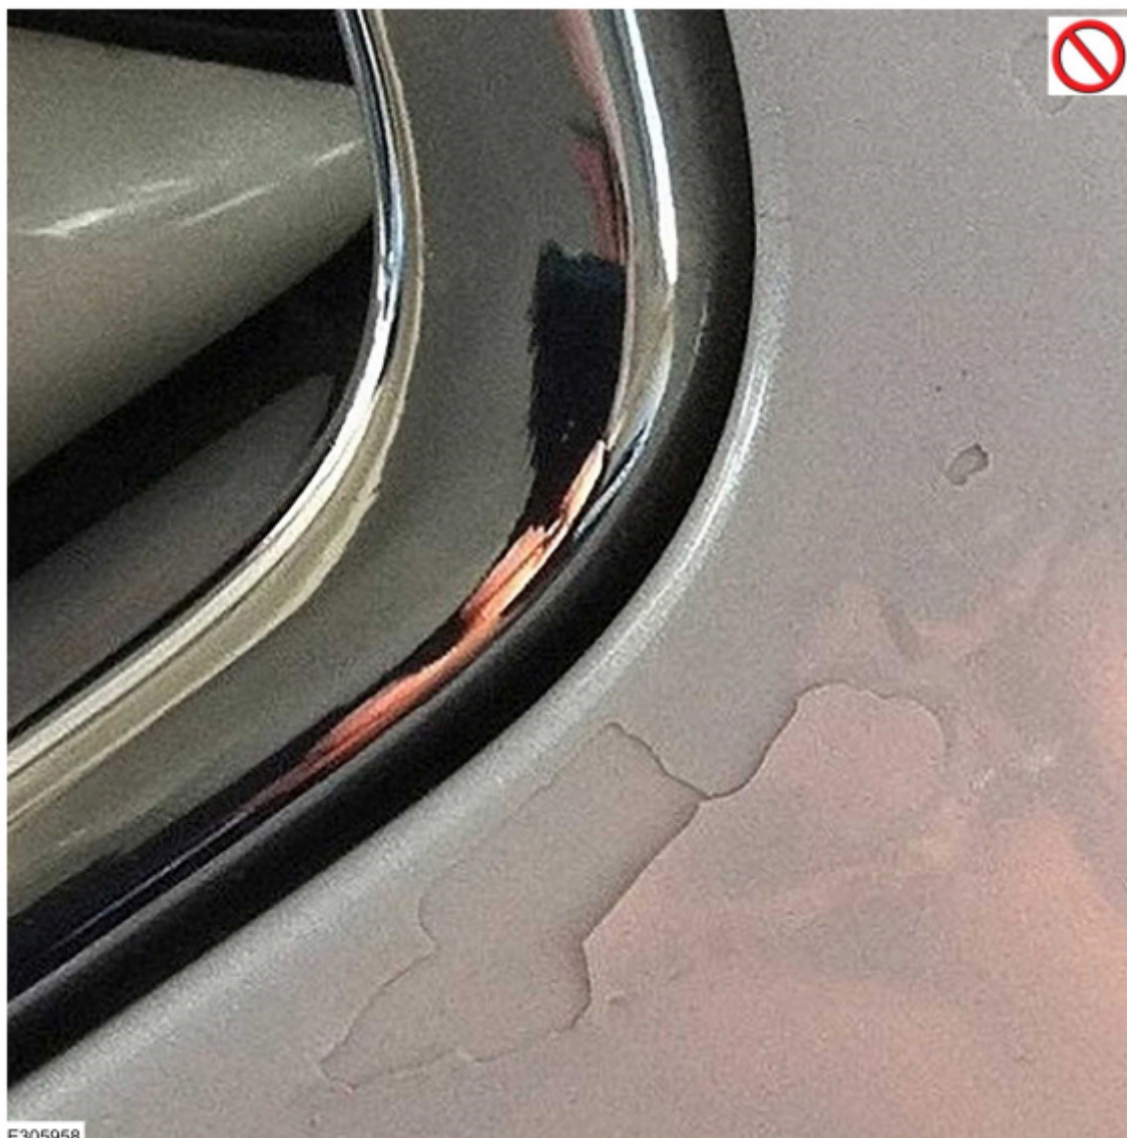
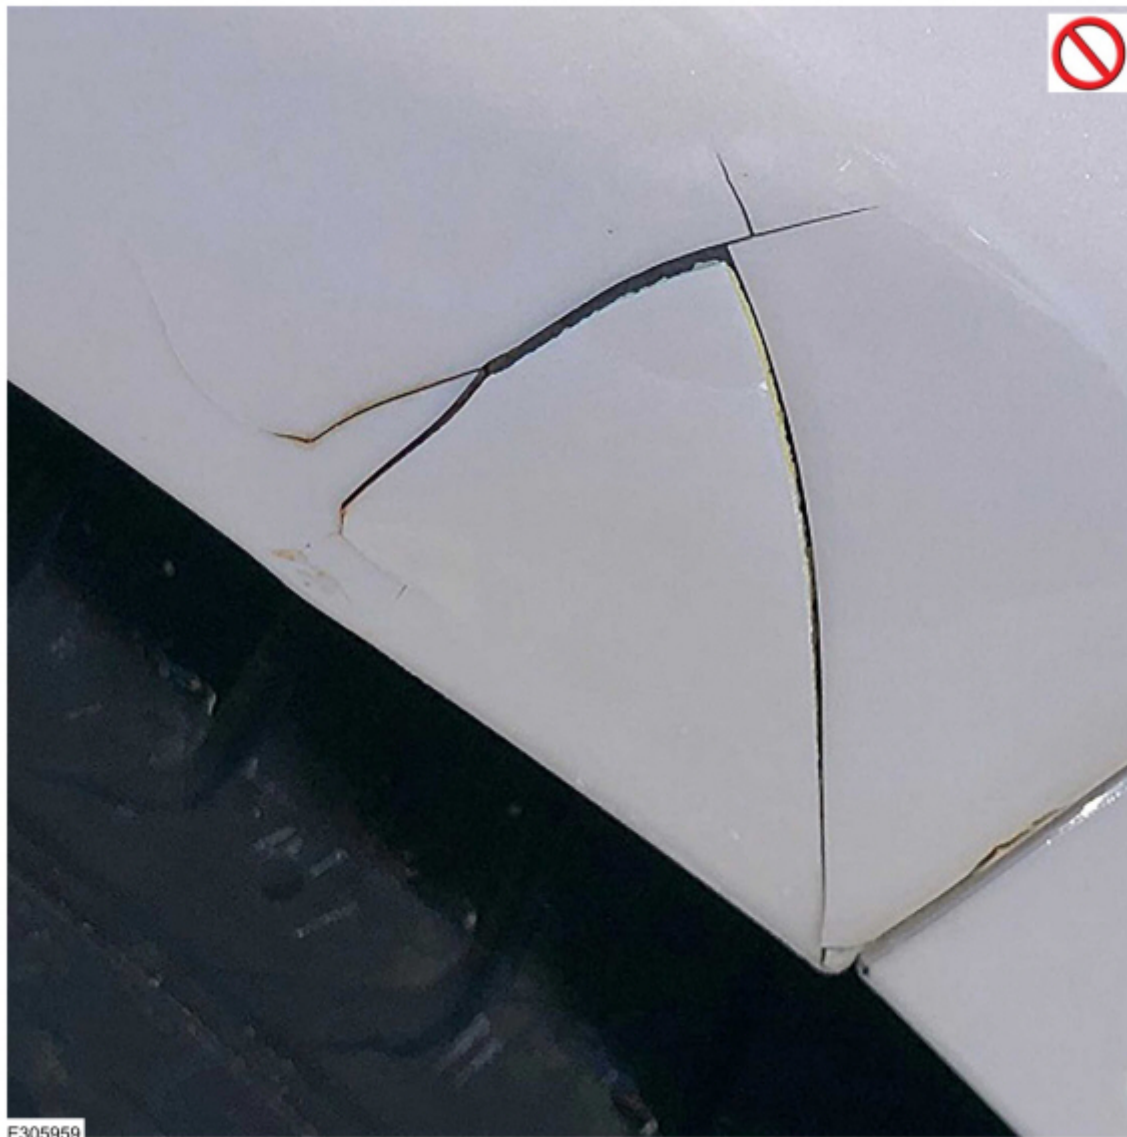
Previous Repair (Non-warrantable)

Indicated by peeling paint atop the same/different color. Visible body filler. (Figures 29-30)

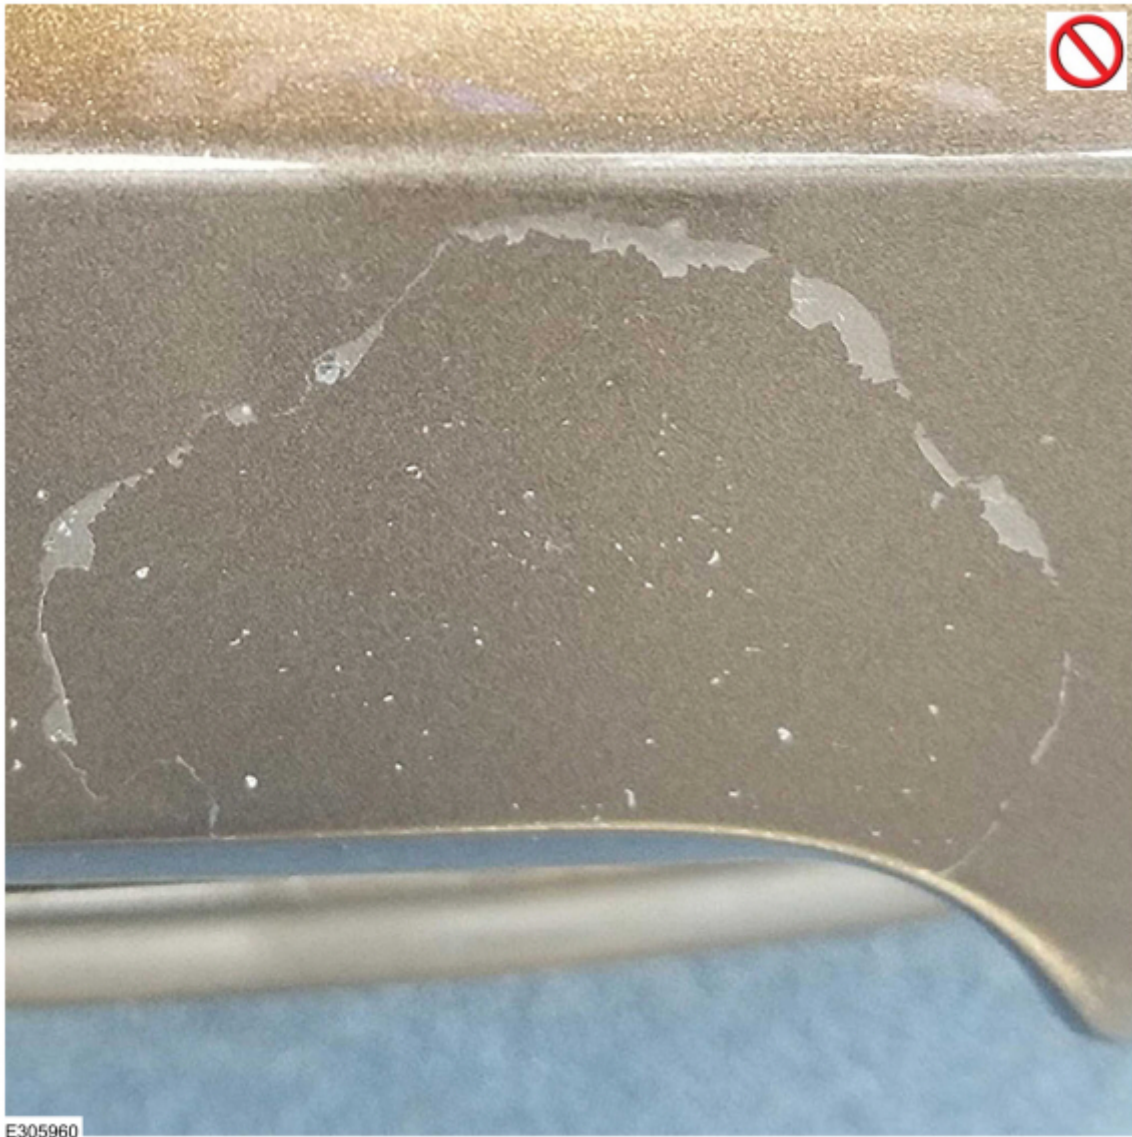
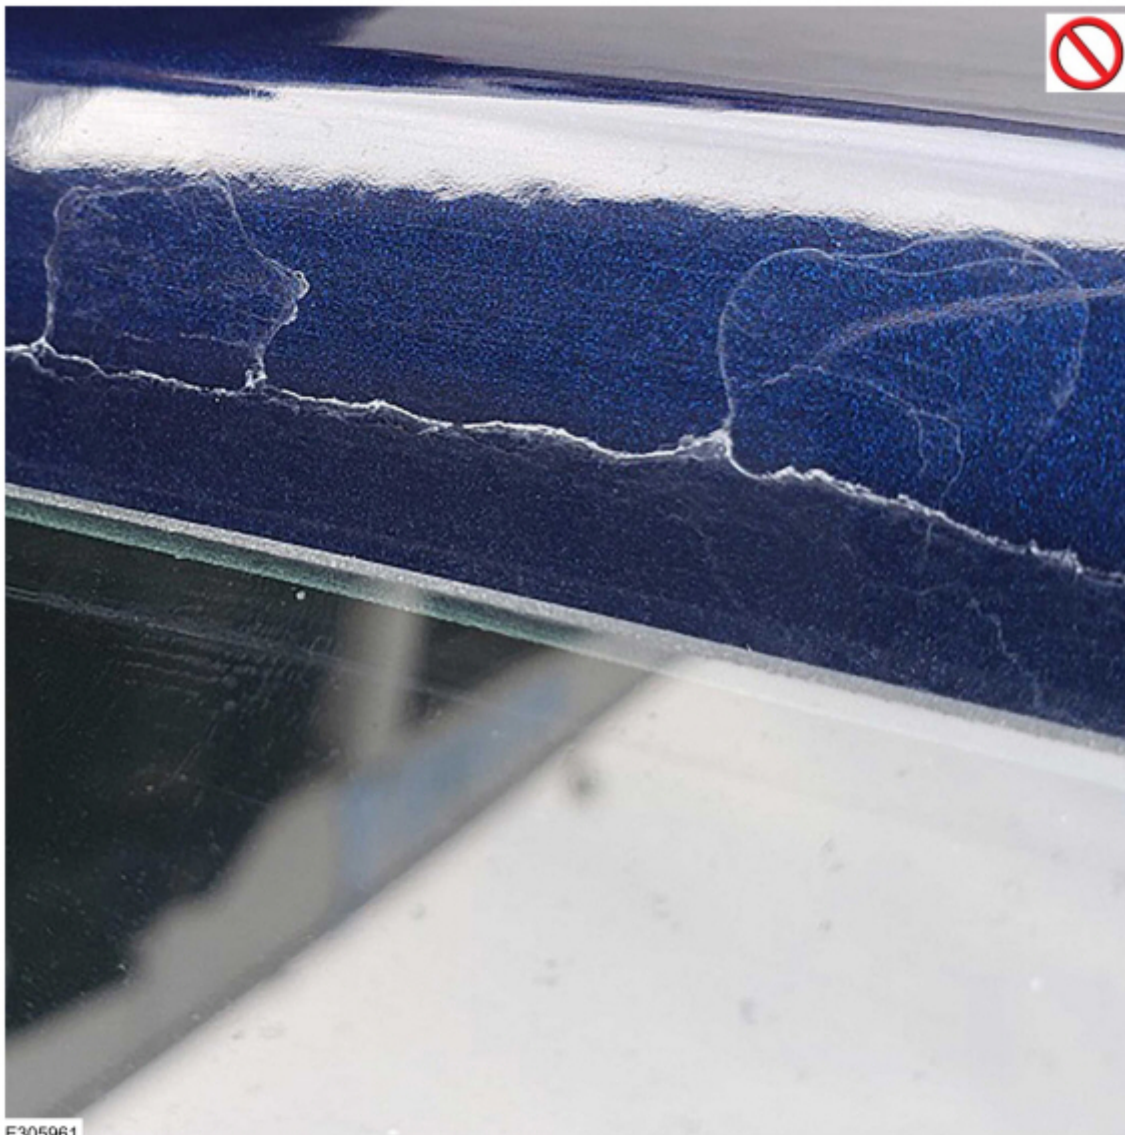
Clear Coat Peeling (Non-warrantable)

The factory paint process bonds color and clear coats together preventing clear coat peeling. (Figures 31-32)
